Access Compliance Report

Public Rights-of-Way

(Curb Ramps)

Intersection ID: 47361	Main Street: PARK_RD	Cross Street: BROOKSIDE_AV	Location: W
ADA ID: A5D5353A7566	Ramp Type: Perp	Initial Pass/Fail: Fail	Overall Compliance: No
			Severity Score: 13.75

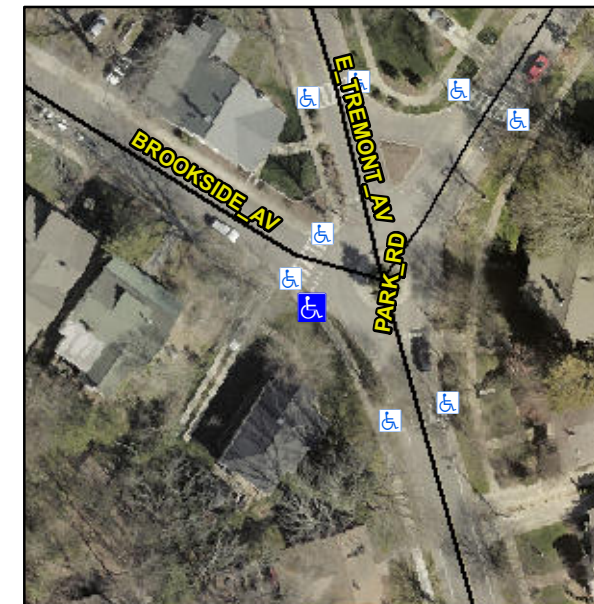
Not Found, R304.2.2, R304.5.3

Compliance	Description	Data	Compliance	Description	Data
N/A	Ramp Length (in)	45.0	No	Ramp Slope (%)	8.8
Yes	Ramp Width (in)	112.0	No	Ramp XSlope (%)	3.0
N/A	Flare Type LT	N/A	N/A	Flare Type RT	N/A
N/A	Flare Slope LT (%)	N/A	N/A	Flare Slope RT (%)	N/A
N/A	Flare Traversable LT?	N/A	N/A	Flare Traversable RT?	N/A
N/A	Landing Length (in)	N/A	N/A	DWS Provided?	N/A
N/A	Landing Width (in)	N/A	N/A	DWS Contrast?	N/A
N/A	Landing Slope (%)	N/A	N/A	DWS Length (in)	N/A
N/A	Landing X Slope (%)	N/A	N/A	DWS Full Width?	N/A
N/A	Landing Curb? (Y/N)	N/A	N/A	DWS Offset (in)	N/A
N/A	Shared Landing?	N/A			
N/A	Gutter Ponding?	N/A	N/A	Gutter Slope (%)	N/A
N/A	Gutter Lip Ht (in)	N/A	N/A	Gutter X Slope (%)	N/A
N/A	Painted X Walk1?	No	N/A	Painted X Walk2?	N/A
	X Walk 1 Direction	To N		X Walk 2 Direction	N/A
N/A	X Walk 1 Width (in)	N/A	N/A	X Walk 2 Width (in)	N/A
	X Walk 1 Slope (%)	2.8		X Walk 2 Slope (%)	N/A
	X Walk 1 X Slope (%)	5.0		X Walk 2 X Slope (%)	N/A

N/A	Ramp inside XWalk1?	N/A	N/A	Ramp inside XWalk2?	N/A
	Road Slope (%)	N/A	N/A	Clear Space?	N/A
	Road X Slope (%)	N/A	N/A	Clear Space to XWalk (in)	N/A
N/A	Any Obstructions?	N/A	N/A	Storm Grate/Utility Hazard?	N/A
	Obstruction Type			Storm Grate/Utility Type	
		N/A			N/A
			Yes	Surface Condition? (G/P)	Good

Remove & Replace Entire Ramp.
