Access Compliance Report

Public Rights-of-Way

(Curb Ramps)

Intersection ID: 50579	Main Street: GREAT_LAUREL_RD	Cross Street: PAPER_TREE_RD	Location: S
ADA ID: A600E64C6462	Ramp Type: Perp	Initial Pass/Fail: Fail	Overall Compliance: No
Codes/Mitigation Info/Possible Solution		Field Measurements/Component Compliance	
Severity Score: 8.75

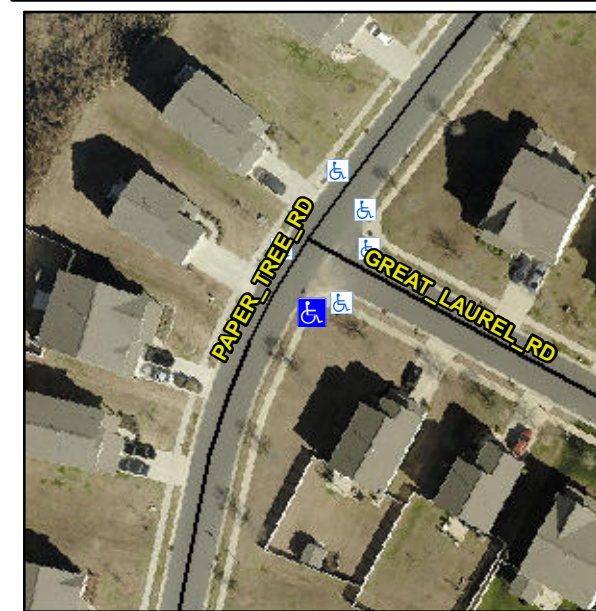
Compliance	Description	Data	Compliance	Description	Data
N/A	Ramp Length (in)	47.5	Yes	Ramp Slope (%)	8.1
No	Ramp Width (in)	47.0	Yes	Ramp XSlope (%)	1.4
N/A	Flare Type LT	N/A	N/A	Flare Type RT	N/A
N/A	Flare Slope LT (%)	N/A	N/A	Flare Slope RT (%)	N/A
N/A	Flare Traversable LT?	N/A	N/A	Flare Traversable RT?	N/A
N/A	Landing Length (in)	N/A	N/A	DWS Provided?	N/A
N/A	Landing Width (in)	N/A	N/A	DWS Contrast?	N/A
N/A	Landing Slope (%)	N/A	N/A	DWS Length (in)	N/A
N/A	Landing X Slope (%)	N/A	N/A	DWS Full Width?	N/A
N/A	Landing Curb? (Y/N)	N/A	N/A	DWS Offset (in)	N/A
N/A	Shared Landing?	N/A			
N/A	Gutter Ponding?	N/A	N/A	Gutter Slope (%)	N/A
N/A	Gutter Lip Ht (in)	N/A	N/A	Gutter X Slope (%)	N/A
N/A	Painted X Walk1?	No	N/A	Painted X Walk2?	N/A
	X Walk 1 Direction	To NW		X Walk 2 Direction	N/A
N/A	X Walk 1 Width (in)	N/A	N/A	X Walk 2 Width (in)	N/A
	X Walk 1 Slope (%)	2.2		X Walk 2 Slope (%)	N/A
	X Walk 1 X Slope (%)	1.6		X Walk 2 X Slope (%)	N/A

N/A	Ramp inside XWalk1?	N/A	N/A	Ramp inside XWalk2?	N/A
	Road Slope (%)	N/A	N/A	Clear Space?	N/A
	Road X Slope (%)	N/A	N/A	Clear Space to XWalk (in)	N/A
N/A	Any Obstructions?	N/A	N/A	Storm Grate/Utility Hazard?	N/A
	Obstruction Type			Storm Grate/Utility Type	
		N/A			N/A
			Yes	Surface Condition? (G/P)	Good

Possible Solutions:

Remove & Replace Entire Ramp.

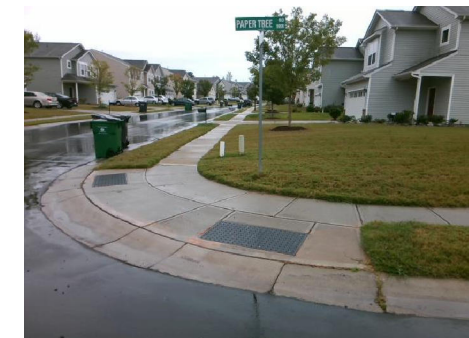
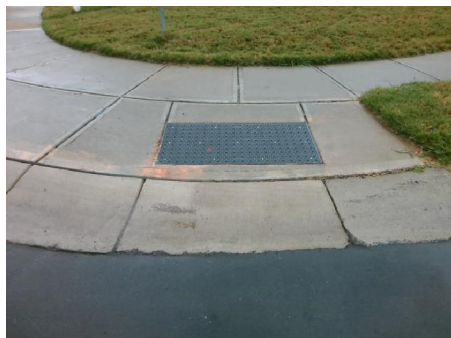
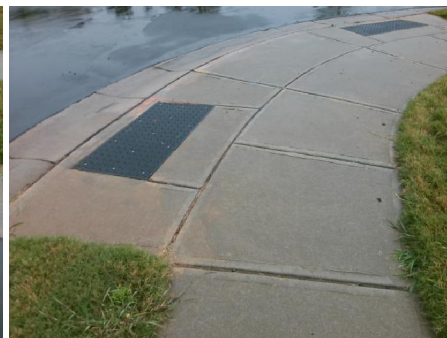
Street 1 Name **PAPER TREE RD**

Stop Condition-Street 2 **None**
