Access Compliance Report

Public Rights-of-Way

(Curb Ramps)

Intersection ID: 10012572	Main Street: TYNER_ST	Cross Street: N/A	Location: NE
ADA ID: A6023E61011E	Ramp Type: Directional1	Initial Pass/Fail: Fail	Overall Compliance: No
		Severity Score: 1.25

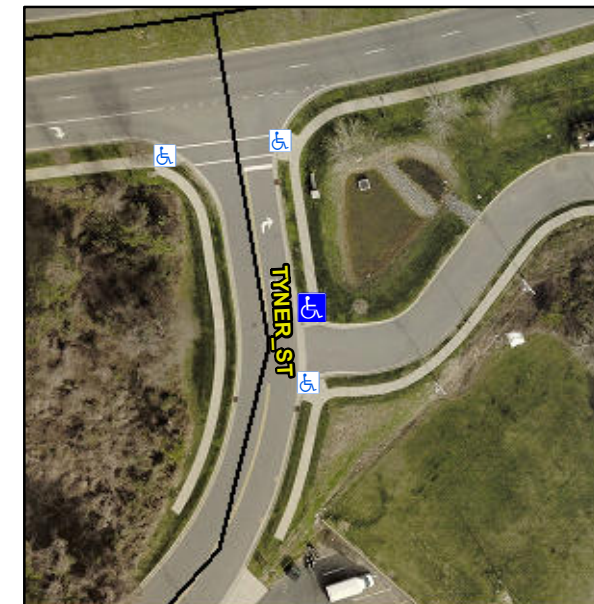
R304.5.3

Compliance	Description	Data	Compliance	Description	Data
N/A	Ramp Length (in)	73.0	N/A	Grade Break?	N/A
Yes	Ramp Width (in)	60.0	N/A	Grade Break Slope (%)	0.0
Yes	Ramp Slope (%)	6.3	N/A	Grade Break XSlope (%)	0.0
No	Ramp XSlope (%)	3.4			
N/A	Flare Type LT	N/A	N/A	Flare Type RT	N/A
N/A	Flare Slope LT (%)	N/A	N/A	Flare Slope RT (%)	0.0
N/A	Flare Traversable LT?	N/A	N/A	Flare Traversable RT?	N/A
N/A	Landing Length (in)	0.0	N/A	DWS Provided?	N/A
N/A	Landing Width (in)	0.0	N/A	DWS Contrast?	N/A
N/A	Landing Slope (%)	0.0	N/A	DWS Length (in)	N/A
N/A	Landing X Slope (%)	0.0	N/A	DWS Full Width?	N/A
N/A	Landing Curb? (Y/N)	N/A	N/A	DWS Offset LT (in)	N/A
N/A	Shared Landing?	N/A	N/A	DWS Offset RT (in)	N/A
N/A	Gutter Ponding?	0.0	N/A	Gutter Slope (%)	N/A
N/A	Gutter Lip Ht (in)	0.0	N/A	Gutter X Slope (%)	N/A
N/A	Painted X Walk1?	No		Road Slope (%)	0.9
	X Walk 1 Direction	To S		Road X Slope (%)	2.9
	X Walk 1 Width (in)	N/A		Clear Space?	N/A

X Walk 1 Slope (%)	0.9	N/A	Clear Space to XWalk (in)	N/A
	X Walk 1 X Slope (%)	2.9	N/A	Storm Grate/Utility Hazard?	N/A
N/A	Ramp inside XWalk1?	N/A		Storm Grate/Utility Type	
N/A	Any Obstructions?	N/A			N/A
	Obstruction Type		Yes	Surface Condition? (G/P)	Good
			N/A	Curb Slope (%)	10.5

Possible Solutions:

Remove & Replace Entire Ramp.

Total Cost: \$ 1600.00
