# Access Compliance Report

## Public Rights-of-Way

### (Curb Ramps)

| Intersection ID: N/A | Main Street: MORABLIN_DR | Cross Street: MERSINGTON_LN | Location: SE |

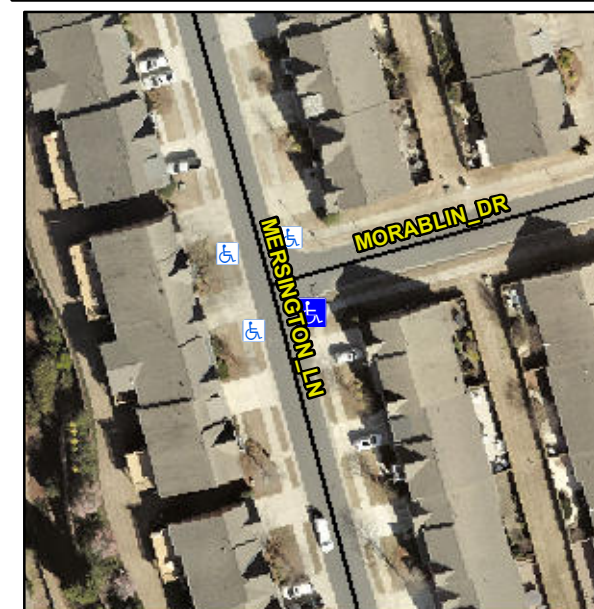
| ADA ID: A606A8F61BC3 | Ramp Type: PerpDiag | Initial Pass/Fail: Fail | Overall Compliance: No |

**Not Found, R304.2.2**

| Compliance | Description | Data | Compliance | Description | Data |
|---|---|---|---|---|---|
| N/A | Ramp Length (in) | 52.0 | No | Ramp Slope (%) | 8.9 |

**Remove & Replace Curb Ramp With Two New Directional Ramps or Equivalent.**

Total Cost: \$ 3200.00
