# Access Compliance Report

## Public Rights-of-Way

### (Curb Ramps)

Intersection ID: 5183	Main Street: GILLMAN_CT	Cross Street: MASON_DR	Location: S
ADA ID: A60E357A7C21	Ramp Type: Perp	Initial Pass/Fail: Fail	Overall Compliance: No
Severity Score: 26.25			
Codes/Mitigation Info/Possible Solution		Field Measurements/Component Compliance

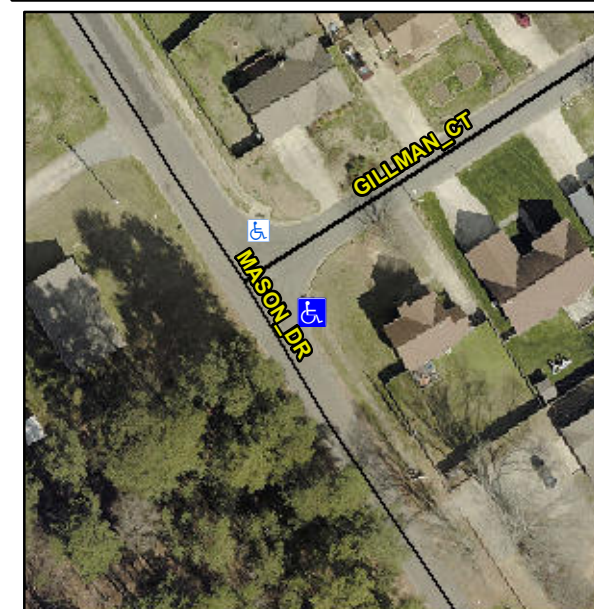
Compliance	Description	Data	Compliance	Description	Data
N/A	Ramp Length (in)	48.0	No	Ramp Slope (%)	15.8
Yes	Ramp Width (in)	48.0	No	Ramp XSlope (%)	2.8
N/A	Flare Type LT	N/A	N/A	Flare Type RT	N/A
N/A	Flare Slope LT (%)	N/A	N/A	Flare Slope RT (%)	N/A
N/A	Flare Traversable LT?	N/A	N/A	Flare Traversable RT?	N/A
N/A	Landing Length (in)	N/A	N/A	DWS Provided?	N/A
N/A	Landing Width (in)	N/A	N/A	DWS Contrast?	N/A
N/A	Landing Slope (%)	N/A	N/A	DWS Length (in)	N/A
N/A	Landing X Slope (%)	N/A	N/A	DWS Full Width?	N/A
N/A	Landing Curb? (Y/N)	N/A	N/A	DWS Offset (in)	N/A
N/A	Shared Landing?	N/A			
N/A	Gutter Ponding?	N/A	N/A	Gutter Slope (%)	N/A
N/A	Gutter Lip Ht (in)	N/A	N/A	Gutter X Slope (%)	N/A
N/A	Painted X Walk1?	No	N/A	Painted X Walk2?	N/A
	X Walk 1 Direction	To NE		X Walk 2 Direction	N/A
N/A	X Walk 1 Width (in)	N/A	N/A	X Walk 2 Width (in)	N/A
	X Walk 1 Slope (%)	1.3		X Walk 2 Slope (%)	N/A
	X Walk 1 X Slope (%)	2.7		X Walk 2 X Slope (%)	N/A

N/A	Ramp inside XWalk1?	N/A	N/A	Ramp inside XWalk2?	N/A
	Road Slope (%)	N/A	N/A	Clear Space?	N/A
	Road X Slope (%)	N/A	N/A	Clear Space to XWalk (in)	N/A
N/A	Any Obstructions?	N/A	N/A	Storm Grate/Utility Hazard?	N/A
	Obstruction Type			Storm Grate/Utility Type	
		N/A			N/A
		Yes		Surface Condition? (G/P)	Good

**Remove & Replace Entire Ramp.**

**R304.2.2, R304.5.3**
