Access Compliance Report

Public Rights-of-Way

(Curb Ramps)

Intersection ID: 30486	Main Street: BEDDINGFIELD_DR	Cross Street: COBBLER_PATCH_CT	Location: NW
ADA ID: A60F49762E6B	Ramp Type: PerpDiag	Initial Pass/Fail: Fail	Overall Compliance: No
Severity Score: 8.75			
Codes/Mitigation Info/Possible Solution		Field Measurements/Component Compliance

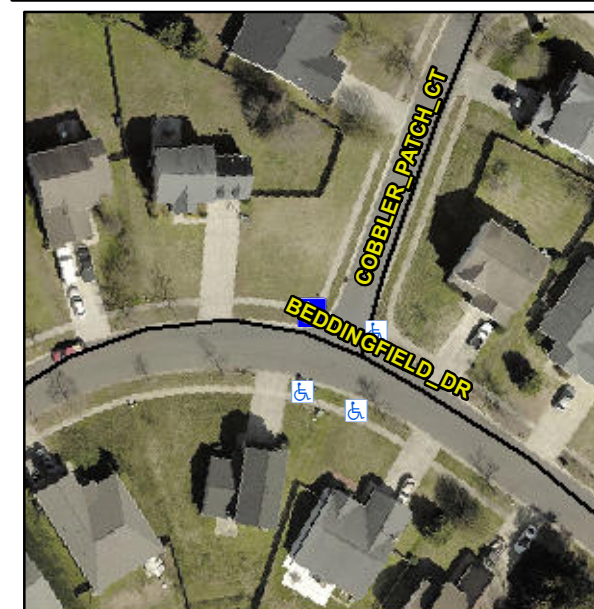
Compliance	Description	Data	Compliance	Description	Data
N/A	Ramp Length (in)	51.0	Yes	Ramp Slope (%)	5.4
No	Ramp Width (in)	47.0	Yes	Ramp XSlope (%)	1.6
N/A	Flare Type LT	N/A	N/A	Flare Type RT	N/A
N/A	Flare Slope LT (%)	N/A	N/A	Flare Slope RT (%)	N/A
N/A	Flare Traversable LT?	N/A	N/A	Flare Traversable RT?	N/A
N/A	Landing Length (in)	N/A	N/A	DWS Provided?	N/A
N/A	Landing Width (in)	N/A	N/A	DWS Contrast?	N/A
N/A	Landing Slope (%)	N/A	N/A	DWS Length (in)	N/A
N/A	Landing X Slope (%)	N/A	N/A	DWS Full Width?	N/A
N/A	Landing Curb? (Y/N)	N/A	N/A	DWS Offset (in)	N/A
N/A	Shared Landing?	N/A			
N/A	Gutter Ponding?	N/A	N/A	Gutter Slope (%)	N/A
N/A	Gutter Lip Ht (in)	N/A	N/A	Gutter X Slope (%)	N/A
N/A	Painted X Walk1?	No	N/A	Painted X Walk2?	No
	X Walk 1 Direction	To SW		X Walk 2 Direction	To SE
N/A	X Walk 1 Width (in)	N/A	N/A	X Walk 2 Width (in)	N/A
	X Walk 1 Slope (%)	4.5		X Walk 2 Slope (%)	2.2
	X Walk 1 X Slope (%)	0.1		X Walk 2 X Slope (%)	3.1

N/A	Ramp inside XWalk1?	N/A	N/A	Ramp inside XWalk2?	N/A
	Road Slope (%)	2.6	N/A	Clear Space?	N/A
	Road X Slope (%)	4.0	N/A	Clear Space to XWalk (in)	N/A
N/A	Any Obstructions?	N/A	N/A	Storm Grate/Utility Hazard?	N/A
	Obstruction Type			Storm Grate/Utility Type	
		N/A			N/A
		Yes		Surface Condition? (G/P)	Good

Possible Solutions:

Remove & Replace Curb Ramp With Two New Directional Ramps or Equivalent.

R304.5.1
