# Access Compliance Report

## Public Rights-of-Way

### (Curb Ramps)

Intersection ID: N/A	Main Street: MAMMOTH_OAKS_DR	Cross Street: N/A	Location: N
ADA ID: A611FDDDD47DC	Ramp Type: Perp	Initial Pass/Fail: Fail	Overall Compliance: No
		Severity Score: 12.5	
Codes/Mitigation Info/Possible Solution		Field Measurements/Component Compliance

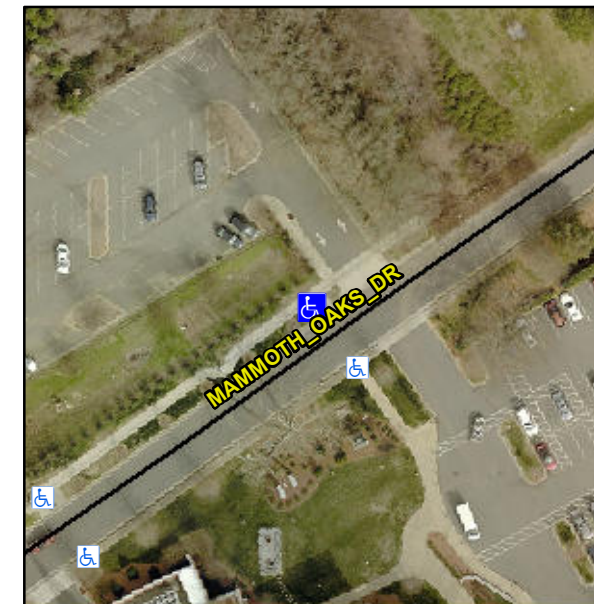
**Not Found, R304.2.2**

Compliance	Description	Data	Compliance	Description	Data
N/A	Ramp Length (in)	96.0	No	Ramp Slope (%)	9.0
Yes	Ramp Width (in)	48.0	Yes	Ramp XSlope (%)	0.7
N/A	Flare Type LT	N/A	N/A	Flare Type RT	N/A
N/A	Flare Slope LT (%)	N/A	N/A	Flare Slope RT (%)	N/A
N/A	Flare Traversable LT?	N/A	N/A	Flare Traversable RT?	N/A
N/A	Landing Length (in)	N/A	N/A	DWS Provided?	N/A
N/A	Landing Width (in)	N/A	N/A	DWS Contrast?	N/A
N/A	Landing Slope (%)	N/A	N/A	DWS Length (in)	N/A
N/A	Landing X Slope (%)	N/A	N/A	DWS Full Width?	N/A
N/A	Landing Curb? (Y/N)	N/A	N/A	DWS Offset (in)	N/A
N/A	Shared Landing?	N/A			
N/A	Gutter Ponding?	N/A	N/A	Gutter Slope (%)	N/A
N/A	Gutter Lip Ht (in)	N/A	N/A	Gutter X Slope (%)	N/A
N/A	Painted X Walk1?	No	N/A	Painted X Walk2?	N/A
	X Walk 1 Direction	To SE		X Walk 2 Direction	N/A
N/A	X Walk 1 Width (in)	N/A	N/A	X Walk 2 Width (in)	N/A
	X Walk 1 Slope (%)	0.7		X Walk 2 Slope (%)	N/A
	X Walk 1 X Slope (%)	2.1		X Walk 2 X Slope (%)	N/A

N/A	Ramp inside XWalk1?	N/A	N/A	Ramp inside XWalk2?	N/A
	Road Slope (%)	N/A	N/A	Clear Space?	N/A
	Road X Slope (%)	N/A	N/A	Clear Space to XWalk (in)	N/A
N/A	Any Obstructions?	N/A	N/A	Storm Grate/Utility Hazard?	N/A
	Obstruction Type			Storm Grate/Utility Type	
		N/A			N/A
			Yes	Surface Condition? (G/P)	Good

**Remove & Replace Entire Ramp.**
