# Access Compliance Report

## Public Rights-of-Way

### (Curb Ramps)

| Intersection ID: 10018977 | Main Street: BLACK_FOX_CT | Cross Street: N/A | Location: S |

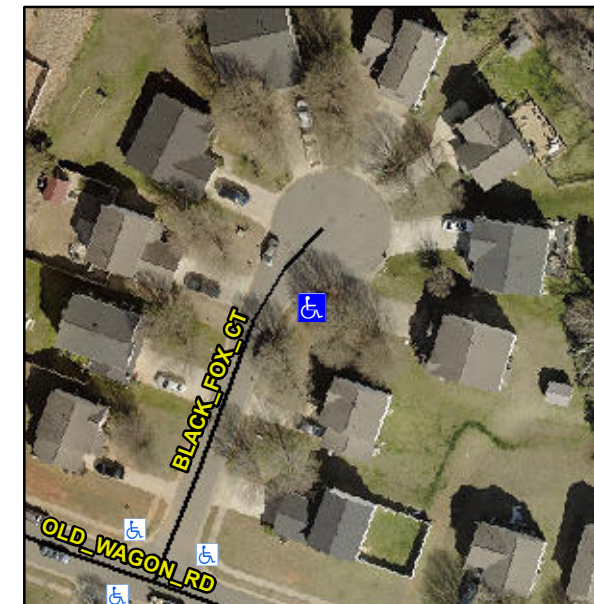
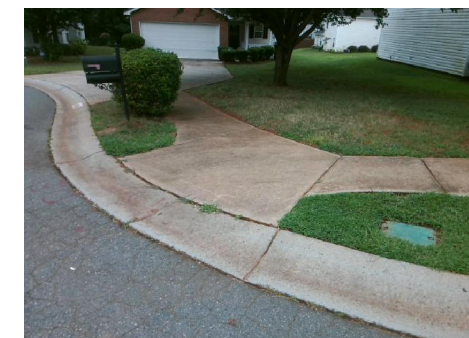
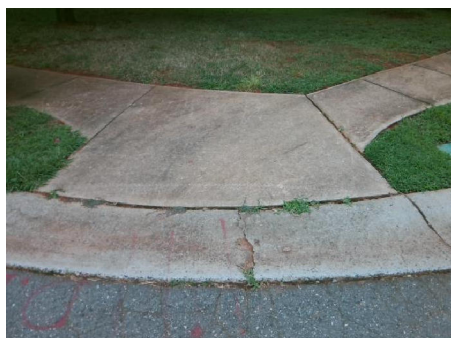
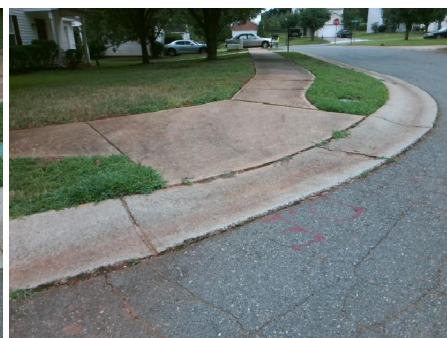
| ADA ID: A62A592AE8BF | Ramp Type: Perp | Initial Pass/Fail: Fail | Overall Compliance: No |

**Not Found, R304.5.3**

| Compliance | Description | Data | Compliance | Description | Data |
|---|---|---|---|---|---|
| Yes | Ramp Width (in) | 73.5 | No | Ramp XSlope (%) | 7.3 |

**Remove & Replace Entire Ramp.**
