Access Compliance Report Public Rights-of-Way (Curb Ramps)

Intersection ID: 13725 Main Str	Cross Street: N_SHARON_AMITY_RD				Location:	NW	
	Main Street: AUBURNDALE_RD						
ADA ID: A62D390372D5 Ramp Type: Perp		Initial Pass/Fail: Fail Overall Compliance: No			o Severity Score:	22.5	
Codes/Mitigation Info/Possible Solution		Field Measurements/Component Compliance					
	Possible Solutions:	Compliance Description Data			Compliance Description Data		
	Remove & Replace Entire Ramp.	N/A	Ramp Length (in)	59.0	No	Ramp Slope (%)	11.2
		No	Ramp Width (in)	44.0	No	Ramp XSlope (%)	4.4
		N/A	Flare Type LT	N/A	N/A	Flare Type RT	N/A
AUBURNDALE ROSE E		N/A	Flare Slope LT (%)	N/A	N/A	Flare Slope RT (%)	N/A
		N/A	Flare Traversable LT?	N/A	N/A	Flare Traversable RT?	N/A
		N/A	Landing Length (in)	N/A	N/A	DWS Provided?	N/A
	Surveyor Notes:	N/A	Landing Width (in)	N/A	N/A	DWS Contrast?	N/A
	N/A	N/A	Landing Slope (%)	N/A	N/A	DWS Length (in)	N/A
		N/A	Landing X Slope (%)	N/A	N/A	DWS Full Width?	N/A

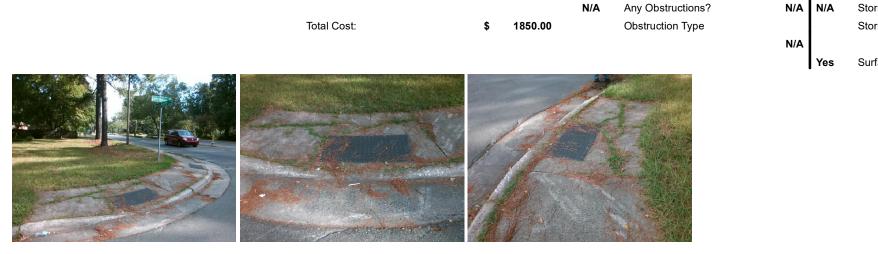
N/A	Landing Curb? (Y/N)	N/A	N/A	DWS Offset (in)	N/A
		N/A	Shared Landing?	N/A			
	PROW/ADA:	N/A	Gutter Ponding?	N/A	N/A	Gutter Slope (%)	N/A
	Not Found, R304.5.1, R304.2.2,	N/A	Gutter Lip Ht (in)	0.5	N/A	Gutter X Slope (%)	N/A
	R304.5.3	N/A	Painted X Walk1?	No	N/A	Painted X Walk2?	N/A
			X Walk 1 Direction	To S		X Walk 2 Direction	N/A
		N/A	X Walk 1 Width (in)	N/A	N/A	X Walk 2 Width (in)	N/A
Street 1 Name AUBURNDALE RD	-		X Walk 1 Slope (%)	2.0		X Walk 2 Slope (%)	N/A
Stop Condition-Street 2 StopSign			X Walk 1 X Slope (%)	2.1		X Walk 2 X Slope (%)	N/A
Street 2 Name N/A		N/A	Ramp inside XWalk1?	N/A	N/A	Ramp inside XWalk2?	N/A
Stop Condition-Street 1 N/A			Road Slope (%)	N/A	N/A	Clear Space?	N/A
			Road X Slope (%)	N/A	N/A	Clear Space to XWalk (in)	N/A
		N/A	Any Obstructions?	N/A	N/A	Storm Grate/Utility Hazard?	N/A
	Total Cost: \$ 1	850.00	Obstruction Type			Storm Grate/Utility Type	
				N/A			N/A
