Access Compliance Report

Public Rights-of-Way

(Curb Ramps)

Intersection ID: 13926	Main Street: PENCE_RD	Cross Street: VIOLA_DR	Location: S
ADA ID: A631183905CB	Ramp Type: Perp	Initial Pass/Fail: Fail	Overall Compliance: No
		Severity Score: 8.75	
Codes/Mitigation Info/Possible Solution		Field Measurements/Component Compliance

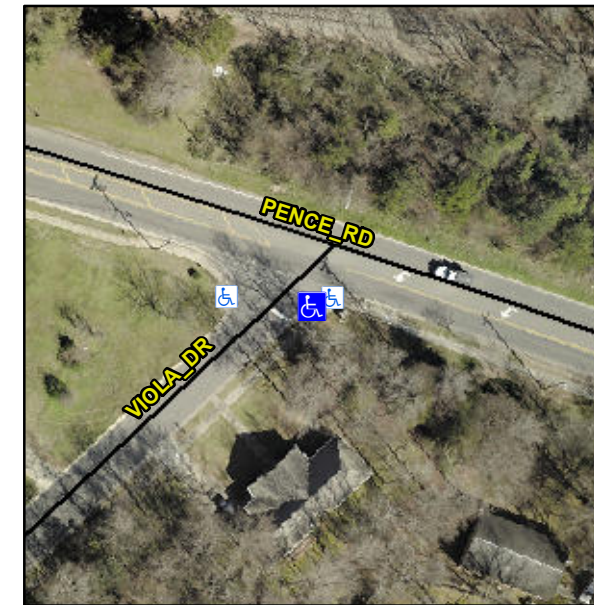
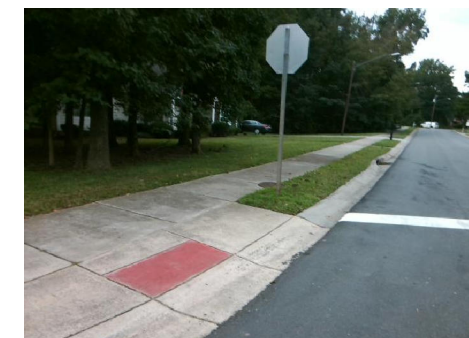
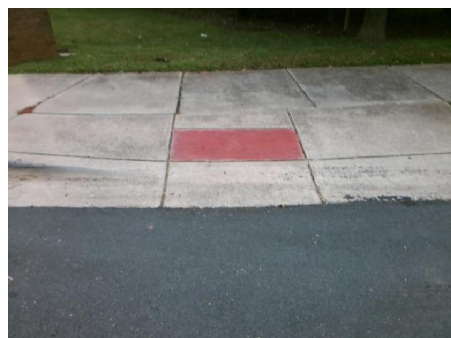
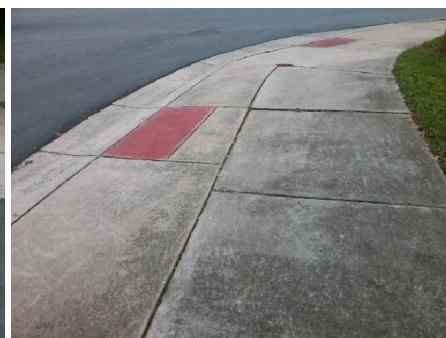
Not Found, R304.5.1

Compliance	Description	Data	Compliance	Description	Data
N/A	Ramp Length (in)	37.5	Yes	Ramp Slope (%)	5.0
No	Ramp Width (in)	46.5	Yes	Ramp XSlope (%)	0.5
N/A	Flare Type LT	N/A	N/A	Flare Type RT	N/A
N/A	Flare Slope LT (%)	N/A	N/A	Flare Slope RT (%)	N/A
N/A	Flare Traversable LT?	N/A	N/A	Flare Traversable RT?	N/A
N/A	Landing Length (in)	N/A	N/A	DWS Provided?	N/A
N/A	Landing Width (in)	N/A	N/A	DWS Contrast?	N/A
N/A	Landing Slope (%)	N/A	N/A	DWS Length (in)	N/A
N/A	Landing X Slope (%)	N/A	N/A	DWS Full Width?	N/A
N/A	Landing Curb? (Y/N)	N/A	N/A	DWS Offset (in)	N/A
N/A	Shared Landing?	N/A			
N/A	Gutter Ponding?	N/A	N/A	Gutter Slope (%)	N/A
N/A	Gutter Lip Ht (in)	N/A	N/A	Gutter X Slope (%)	N/A
N/A	Painted X Walk1?	No	N/A	Painted X Walk2?	N/A
	X Walk 1 Direction	To W		X Walk 2 Direction	N/A
N/A	X Walk 1 Width (in)	N/A	N/A	X Walk 2 Width (in)	N/A
	X Walk 1 Slope (%)	3.6		X Walk 2 Slope (%)	N/A
	X Walk 1 X Slope (%)	1.0		X Walk 2 X Slope (%)	N/A

N/A	Ramp inside XWalk1?	N/A	N/A	Ramp inside XWalk2?	N/A
	Road Slope (%)	N/A	N/A	Clear Space?	N/A
	Road X Slope (%)	N/A	N/A	Clear Space to XWalk (in)	N/A
N/A	Any Obstructions?	N/A	N/A	Storm Grate/Utility Hazard?	N/A
	Obstruction Type			Storm Grate/Utility Type	
		N/A			N/A
			Yes	Surface Condition? (G/P)	Good

Remove & Replace Entire Ramp.
