Access Compliance Report

Public Rights-of-Way

(Curb Ramps)

Intersection ID: 50591	Main Street: GREEN_GRASS_RD	Cross Street: LONGSTRAW_RD	Location: SE
ADA ID: A633DACFC5B4	Ramp Type: Perp	Initial Pass/Fail: Fail	Overall Compliance: No
Severity Score: 10			
Codes/Mitigation Info/Possible Solution		Field Measurements/Component Compliance

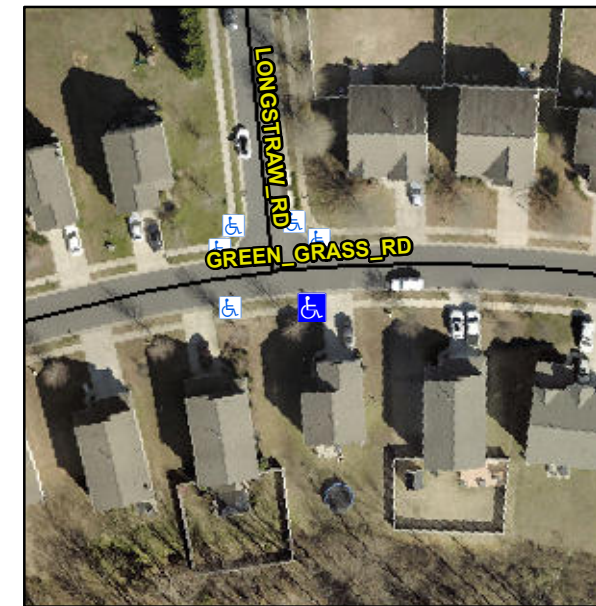
Compliance	Description	Data	Compliance	Description	Data
N/A	Ramp Length (in)	47.5	Yes	Ramp Slope (%)	8.2
No	Ramp Width (in)	45.5	No	Ramp XSlope (%)	3.7
N/A	Flare Type LT	N/A	N/A	Flare Type RT	N/A
N/A	Flare Slope LT (%)	N/A	N/A	Flare Slope RT (%)	N/A
N/A	Flare Traversable LT?	N/A	N/A	Flare Traversable RT?	N/A
N/A	Landing Length (in)	N/A	N/A	DWS Provided?	N/A
N/A	Landing Width (in)	N/A	N/A	DWS Contrast?	N/A
N/A	Landing Slope (%)	N/A	N/A	DWS Length (in)	N/A
N/A	Landing X Slope (%)	N/A	N/A	DWS Full Width?	N/A
N/A	Landing Curb? (Y/N)	N/A	N/A	DWS Offset (in)	N/A
N/A	Shared Landing?	N/A			
N/A	Gutter Ponding?	N/A	N/A	Gutter Slope (%)	N/A
N/A	Gutter Lip Ht (in)	N/A	N/A	Gutter X Slope (%)	N/A
N/A	Painted X Walk1?	No	N/A	Painted X Walk2?	N/A
	X Walk 1 Direction	To N		X Walk 2 Direction	N/A
N/A	X Walk 1 Width (in)	N/A	N/A	X Walk 2 Width (in)	N/A
	X Walk 1 Slope (%)	1.2		X Walk 2 Slope (%)	N/A
	X Walk 1 X Slope (%)	3.2		X Walk 2 X Slope (%)	N/A

N/A	Ramp inside XWalk1?	N/A	N/A	Ramp inside XWalk2?	N/A
	Road Slope (%)	N/A	N/A	Clear Space?	N/A
	Road X Slope (%)	N/A	N/A	Clear Space to XWalk (in)	N/A
N/A	Any Obstructions?	N/A	N/A	Storm Grate/Utility Hazard?	N/A
	Obstruction Type			Storm Grate/Utility Type	
		N/A			N/A
			Yes	Surface Condition? (G/P)	Good

Possible Solutions:

Remove & Replace Entire Ramp.
