# Access Compliance Report

## Public Rights-of-Way

### (Curb Ramps)

| Intersection ID: 46190 | Main Street: YAUPON_RD | Cross Street: LUSTRE_RD | Location: NW |

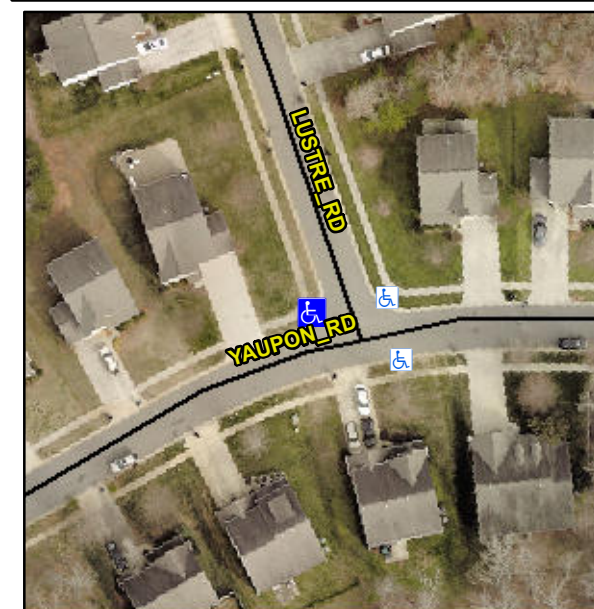
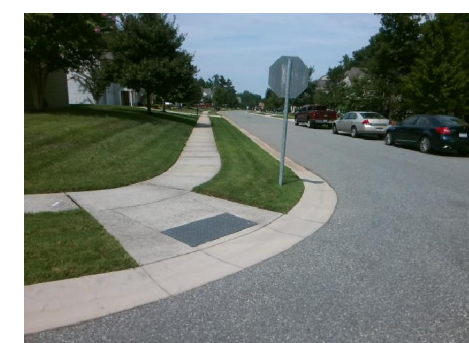
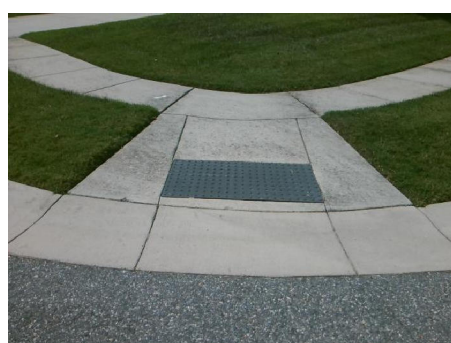
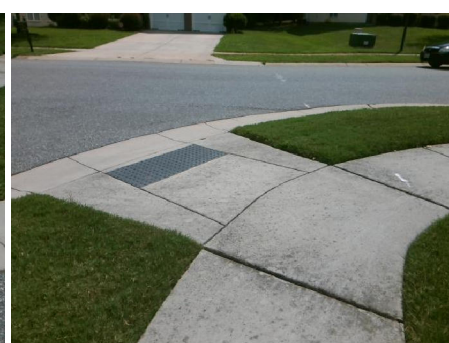
**Not Found, R304.5.3, R304.2.1, R305.2**

| Compliance | Description | Data | Compliance | Description | Data |
|---|---|---|---|---|---|
| Yes | Ramp Width (in) | 48.0 | No | Ramp XSlope (%) | 3.7 |
| No | Landing Length (in) | 46.5 | Yes | DWS Provided? | Yes |
| No | Landing X Slope (%) | 5.0 | Yes | DWS Full Width? | Yes |
| Yes | Gutter Lip Ht (in) | 0.0 | No | Gutter X Slope (%) | 3.9 |

**Remove & Replace Curb Ramp With Two New Directional Ramps or Equivalent. Remove & Replace Gutter.**

Total Cost: \$ 3950.00
