Access Compliance Report

Public Rights-of-Way

(Curb Ramps)

Intersection ID: 16412	Main Street: COLVILLE_RD	Cross Street: TWIFORD_PL	Location: S
ADA ID: A6404C7C9CB5	Ramp Type: BlendTrans2	Initial Pass/Fail: Fail	Overall Compliance: No
		Severity Score: 1.25

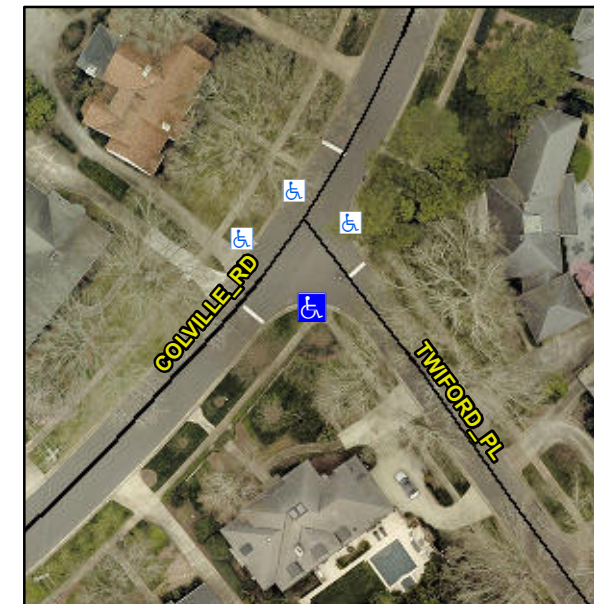
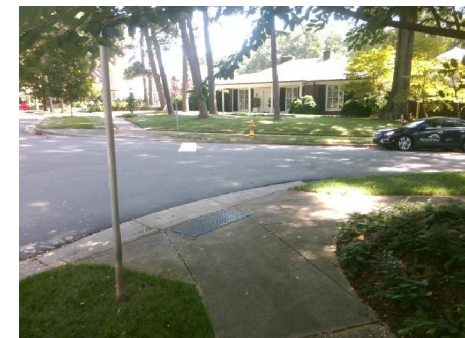
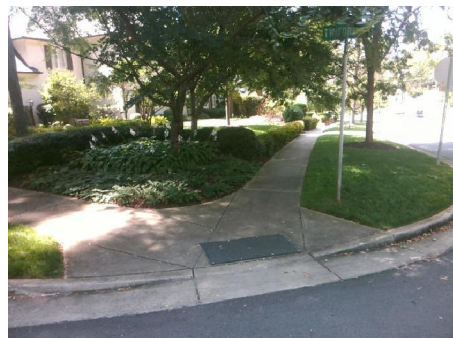
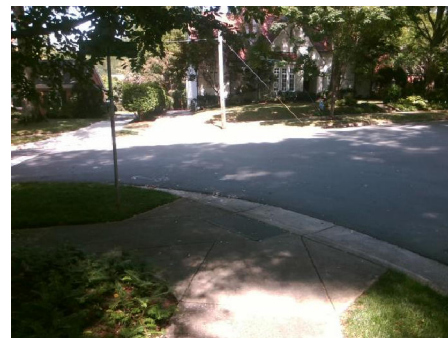
Compliance	Description	Data	Compliance	Description	Data
N/A	Ramp Length (in)	94.5	Yes	BlendTrans Slope (%)	3.3
Yes	Ramp Width (in)	60.0	No	BlendTrans XSlope (%)	4.9
N/A	Flare Type LT	N/A	N/A	Flare Type RT	N/A
N/A	Flare Slope LT (%)	N/A	N/A	Flare Slope RT (%)	N/A
N/A	Flare Traversable LT?	N/A	N/A	Flare Traversable RT?	N/A
N/A	Landing Length (in)	N/A	N/A	DWS Provided?	N/A
N/A	Landing Width (in)	N/A	N/A	DWS Contrast?	N/A
N/A	Landing Slope (%)	N/A	N/A	DWS Length (in)	N/A
N/A	Landing X Slope (%)	N/A	N/A	DWS Full Width?	N/A
N/A	Landing Curb? (Y/N)	N/A	N/A	DWS Offset (in)	N/A
N/A	Shared Landing?	N/A			
N/A	Gutter Ponding?	N/A	N/A	Gutter Slope (%)	N/A
N/A	Gutter Lip Ht (in)	N/A	N/A	Gutter X Slope (%)	N/A
N/A	Painted X Walk1?	No	N/A	Painted X Walk2?	No
	X Walk 1 Direction	To NE		X Walk 2 Direction	To NW
	X Walk 1 Width (in)	N/A		X Walk 2 Width (in)	N/A
	X Walk 1 Slope (%)	6.8		X Walk 2 Slope (%)	2.1
	X Walk 1 X Slope (%)	1.3		X Walk 2 X Slope (%)	8.5

N/A	Ramp inside XWalk1?	N/A	N/A	Ramp inside XWalk2?	N/A
	Road Slope (%)	3.2		Clear Space?	N/A
	Road X Slope (%)	7.2	N/A	Clear Space to XWalk (in)	N/A
N/A	Any Obstructions?	N/A	N/A	Storm Grate/Utility Hazard?	N/A
	Obstruction Type			Storm Grate/Utility Type	
		N/A			N/A
			Yes	Surface Condition? (G/P)	Good
			N/A	Curb Slope (%)	0.4

Remove & Replace Curb Ramp With Two New Directional Ramps or Equivalent.

R304.5.3

\$ 3200.00
