# Access Compliance Report

## Public Rights-of-Way

| Intersection ID: 28787 | Main Street: N_ALEXANDER_ST | Cross Street: PARKSIDE_TERRACE_LN | Location: N |
| ADA ID: A654C5B56D2D | Ramp Type: Perp | Initial Pass/Fail: Fail | Overall Compliance: No |

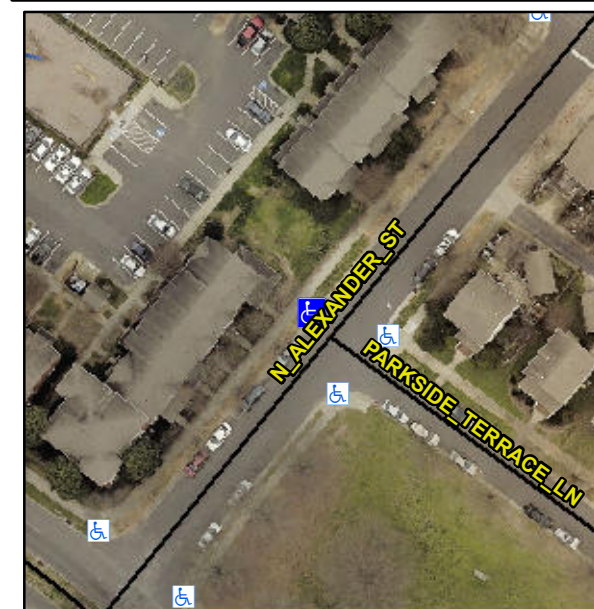
| Severity Score: 12.5 | | | |

**Not Found, R304.2.2**

| Compliance | Description | Data | Compliance | Description | Data |
|---|---|---|---|---|---|
| N/A | Ramp Length (in) | 72.0 | No | Ramp Slope (%) | 8.7 |

**Remove & Replace Entire Ramp.**

Total Cost: \$ 1850.00
