# Access Compliance Report

## Public Rights-of-Way

### (Curb Ramps)

Intersection ID: 6449	Main Street: FAIRES_FARM_RD	Cross Street: TERESA_JILL_DR	Location: SE
ADA ID: A65B1BDFC974	Ramp Type: Perp	Initial Pass/Fail: Fail	Overall Compliance: No
Severity Score: 37.5			
Codes/Mitigation Info/Possible Solution		Field Measurements/Component Compliance

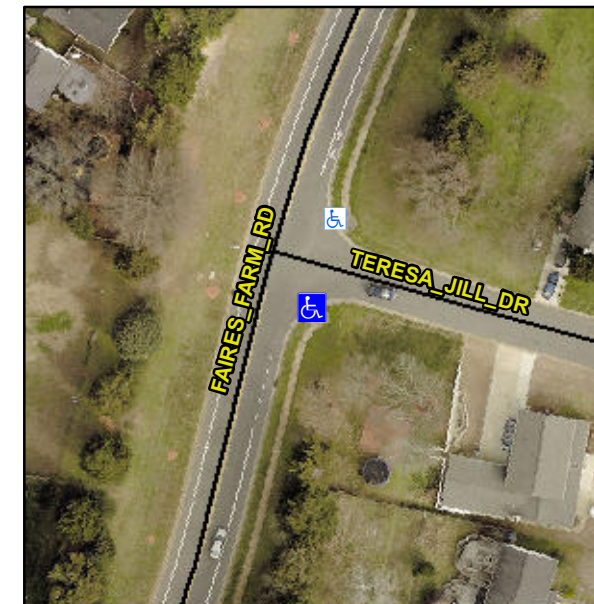
**Not Found, R304.2.2, R304.5.3**

Compliance	Description	Data	Compliance	Description	Data
N/A	Ramp Length (in)	59.0	No	Ramp Slope (%)	8.7
Yes	Ramp Width (in)	48.0	No	Ramp XSlope (%)	9.0
N/A	Flare Type LT	N/A	N/A	Flare Type RT	N/A
N/A	Flare Slope LT (%)	N/A	N/A	Flare Slope RT (%)	N/A
N/A	Flare Traversable LT?	N/A	N/A	Flare Traversable RT?	N/A
N/A	Landing Length (in)	N/A	N/A	DWS Provided?	N/A
N/A	Landing Width (in)	N/A	N/A	DWS Contrast?	N/A
N/A	Landing Slope (%)	N/A	N/A	DWS Length (in)	N/A
N/A	Landing X Slope (%)	N/A	N/A	DWS Full Width?	N/A
N/A	Landing Curb? (Y/N)	N/A	N/A	DWS Offset (in)	N/A
N/A	Shared Landing?	N/A			
N/A	Gutter Ponding?	N/A	N/A	Gutter Slope (%)	N/A
N/A	Gutter Lip Ht (in)	N/A	N/A	Gutter X Slope (%)	N/A
N/A	Painted X Walk1?	No	N/A	Painted X Walk2?	N/A
	X Walk 1 Direction	To N		X Walk 2 Direction	N/A
N/A	X Walk 1 Width (in)	N/A	N/A	X Walk 2 Width (in)	N/A
	X Walk 1 Slope (%)	2.4		X Walk 2 Slope (%)	N/A
	X Walk 1 X Slope (%)	3.6		X Walk 2 X Slope (%)	N/A

N/A	Ramp inside XWalk1?	N/A	N/A	Ramp inside XWalk2?	N/A
	Road Slope (%)	N/A	N/A	Clear Space?	N/A
	Road X Slope (%)	N/A	N/A	Clear Space to XWalk (in)	N/A
N/A	Any Obstructions?	N/A	N/A	Storm Grate/Utility Hazard?	N/A
	Obstruction Type			Storm Grate/Utility Type	
		N/A			N/A
			Yes	Surface Condition? (G/P)	Good

Possible Solutions:

**Remove & Replace Entire Ramp.**
