# Access Compliance Report

## Public Rights-of-Way

### (Curb Ramps)

Intersection ID: 10427	Main Street: CALLAHAN_ST	Cross Street: POLK_ST	Location: NE
ADA ID: A668FE7D1739	Ramp Type: Perp	Initial Pass/Fail: Fail	Overall Compliance: No
Codes/Mitigation Info/Possible Solution		Field Measurements/Component Compliance

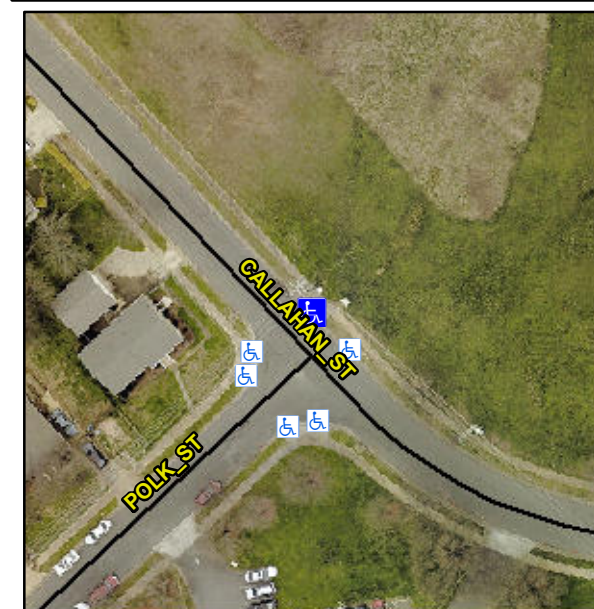
**Not Found, R304.5.1, R304.2.2**

Compliance	Description	Data	Compliance	Description	Data
N/A	Ramp Length (in)	57.0	No	Ramp Slope (%)	9.7
No	Ramp Width (in)	42.0	Yes	Ramp XSlope (%)	0.7
N/A	Flare Type LT	N/A	N/A	Flare Type RT	N/A
N/A	Flare Slope LT (%)	N/A	N/A	Flare Slope RT (%)	N/A
N/A	Flare Traversable LT?	N/A	N/A	Flare Traversable RT?	N/A
N/A	Landing Length (in)	N/A	N/A	DWS Provided?	N/A
N/A	Landing Width (in)	N/A	N/A	DWS Contrast?	N/A
N/A	Landing Slope (%)	N/A	N/A	DWS Length (in)	N/A
N/A	Landing X Slope (%)	N/A	N/A	DWS Full Width?	N/A
N/A	Landing Curb? (Y/N)	N/A	N/A	DWS Offset (in)	N/A
N/A	Shared Landing?	N/A			
N/A	Gutter Ponding?	N/A	N/A	Gutter Slope (%)	N/A
N/A	Gutter Lip Ht (in)	2.5	N/A	Gutter X Slope (%)	N/A
N/A	Painted X Walk1?	No	N/A	Painted X Walk2?	N/A
	X Walk 1 Direction	To SW		X Walk 2 Direction	N/A
N/A	X Walk 1 Width (in)	N/A	N/A	X Walk 2 Width (in)	N/A
	X Walk 1 Slope (%)	6.0		X Walk 2 Slope (%)	N/A
	X Walk 1 X Slope (%)	0.3		X Walk 2 X Slope (%)	N/A

**Remove & Replace Entire Ramp.**
