# Access Compliance Report

## Public Rights-of-Way

### (Curb Ramps)

| Intersection ID: 46813 | Main Street: ARBOR_VISTA_DR | Cross Street: OLDE_IVY_WY | Location: NW |

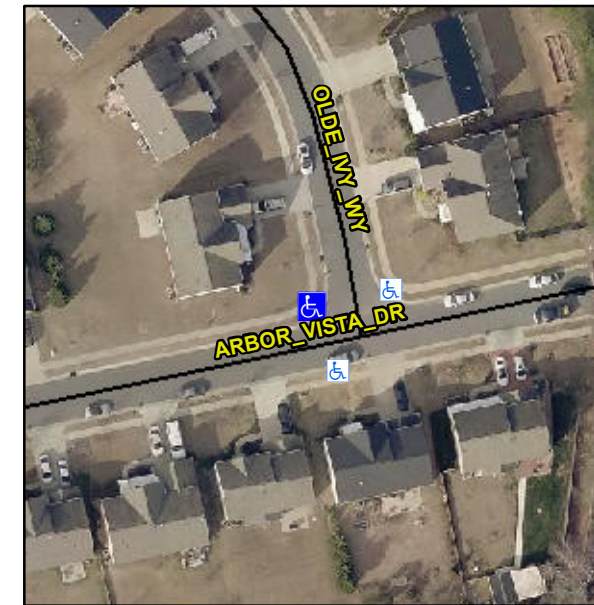
| ADA ID: A670DA7E8472 | Ramp Type: BlendTrans1 | Initial Pass/Fail: Pass | Overall Compliance: No |
| | | | Severity Score: 5.25 |

**Not Found, R304.5.3, R304.2.2-Perp, R304.3.2-Para, R305.2, R304.5.4**

| Compliance | Description | Data | Compliance | Description | Data |
|---|---|---|---|---|---|
| Yes | Ramp Width (in) | 48.0 | No | BlendTrans XSlope (%) | 2.6 |
| No | Landing Slope (%) | 4.6 | Yes | DWS Length (in) | 24.0 |
| N/A | Landing Curb? (Y/N) | No | No | DWS Offset (in) | 5.5 |
| Yes | Gutter Ponding? | No | No | Gutter Slope (%) | 7.5 |
| | | | No | Curb Slope (%) | 15.9 |

Possible Solutions:

**Remove & Replace Curb Ramp With Two New Directional Ramps or Equivalent. Remove & Replace Gutter.**

Total Cost: \$ 3950.00
