Access Compliance Report

Public Rights-of-Way

(Curb Ramps)

Intersection ID: 19937	Main Street: S_TRYON_ST	Cross Street: THORNFIELD_RD	Location: SE
ADA ID: A67AD0D178AD	Ramp Type: Perp	Initial Pass/Fail: Fail	Overall Compliance: No
		Severity Score: 15

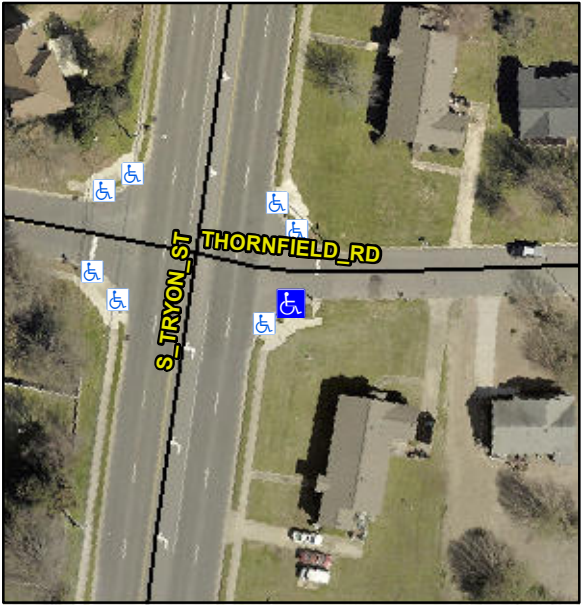
Possible Solutions:		Compliance	Description	Data
	Remove & Replace Entire Ramp.		N/A	Ramp Length (in)	97.0
			Yes	Ramp Width (in)	60.0
			N/A	Flare Type LT	N/A
			N/A	Flare Slope LT (%)	N/A
			N/A	Flare Traversable LT?	N/A
			N/A	Landing Length (in)	N/A
			N/A	Landing Width (in)	N/A
			N/A	Landing Slope (%)	N/A
			N/A	Landing X Slope (%)	N/A
<p>Surveyor Notes:</p> <p>N/A</p> <p>PROW/ADA:</p> <p>R304.2.2, R304.5.3, R302.7</p>			N/A	Flare Type RT	N/A
			N/A	Flare Slope RT (%)	N/A
			N/A	Flare Traversable RT?	N/A
			N/A	DWS Provided?	N/A
			N/A	DWS Contrast?	N/A
			N/A	DWS Length (in)	N/A
			N/A	DWS Full Width?	N/A
			N/A	DWS Offset (in)	N/A
			N/A	Shared Landing?	N/A
			N/A	Gutter Ponding?	N/A
			N/A	Gutter Lip Ht (in)	N/A
			N/A	Painted X Walk1?	No
				X Walk 1 Direction	To N
			N/A	X Walk 1 Width (in)	N/A
				X Walk 1 Slope (%)	6.9

X Walk 1 X Slope (%)	2.2
			N/A	Ramp inside XWalk1?	N/A
				Road Slope (%)	N/A
				Road X Slope (%)	N/A
			N/A	Any Obstructions?	N/A
				Obstruction Type	
Total Cost:		\$ 1850.00			
			N/A		
			No	Surface Condition? (G/P)	Poor
