Access Compliance Report

Public Rights-of-Way

(Curb Ramps)

Intersection ID: 10035321	Main Street: RADCLIFFE_AV	Cross Street: QUEENS_RD_WEST	Location: SW
ADA ID: A6823CD465EC	Ramp Type: Perp	Initial Pass/Fail: Fail	Overall Compliance: No
Severity Score: 22.5			
Codes/Mitigation Info/Possible Solution		Field Measurements/Component Compliance

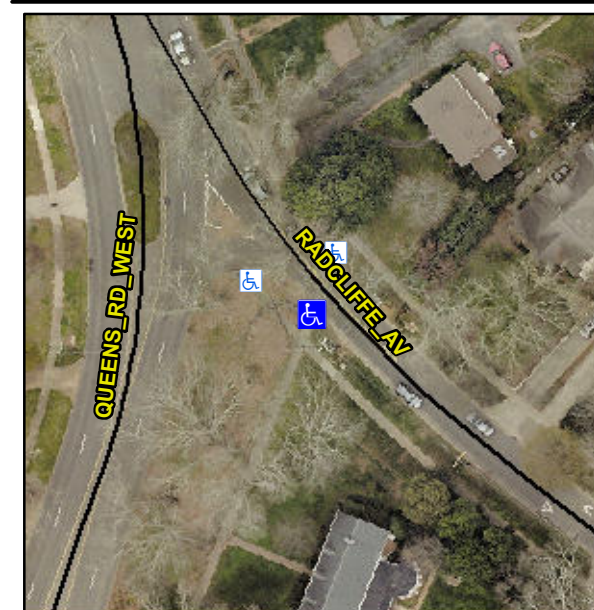
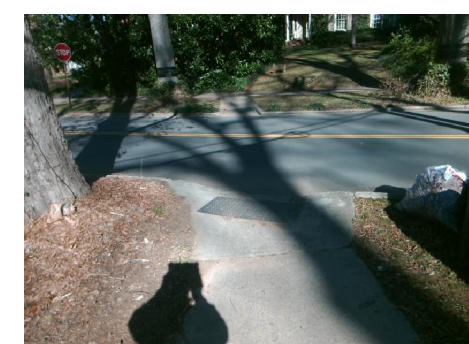
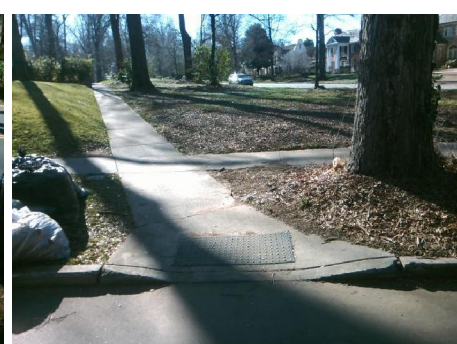
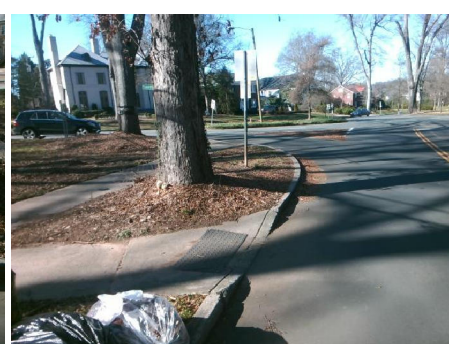
R304.5.1, R304.2.2, R304.5.3

Compliance	Description	Data	Compliance	Description	Data
N/A	Ramp Length (in)	54.0	No	Ramp Slope (%)	9.2
No	Ramp Width (in)	46.0	No	Ramp XSlope (%)	2.2
N/A	Flare Type LT	N/A	N/A	Flare Type RT	N/A
N/A	Flare Slope LT (%)	N/A	N/A	Flare Slope RT (%)	N/A
N/A	Flare Traversable LT?	N/A	N/A	Flare Traversable RT?	N/A
N/A	Landing Length (in)	N/A	N/A	DWS Provided?	N/A
N/A	Landing Width (in)	N/A	N/A	DWS Contrast?	N/A
N/A	Landing Slope (%)	N/A	N/A	DWS Length (in)	N/A
N/A	Landing X Slope (%)	N/A	N/A	DWS Full Width?	N/A
N/A	Landing Curb? (Y/N)	N/A	N/A	DWS Offset (in)	N/A
N/A	Shared Landing?	N/A			
N/A	Gutter Ponding?	N/A	N/A	Gutter Slope (%)	N/A
N/A	Gutter Lip Ht (in)	N/A	N/A	Gutter X Slope (%)	N/A
N/A	Painted X Walk1?	No	N/A	Painted X Walk2?	N/A
	X Walk 1 Direction	To NE		X Walk 2 Direction	N/A
N/A	X Walk 1 Width (in)	N/A	N/A	X Walk 2 Width (in)	N/A
	X Walk 1 Slope (%)	2.1		X Walk 2 Slope (%)	N/A
	X Walk 1 X Slope (%)	1.6		X Walk 2 X Slope (%)	N/A

N/A	Ramp inside XWalk1?	N/A	N/A	Ramp inside XWalk2?	N/A
	Road Slope (%)	N/A	N/A	Clear Space?	N/A
	Road X Slope (%)	N/A	N/A	Clear Space to XWalk (in)	N/A
N/A	Any Obstructions?	N/A	N/A	Storm Grate/Utility Hazard?	N/A
	Obstruction Type			Storm Grate/Utility Type	
		N/A			N/A
			Yes	Surface Condition? (G/P)	Good

Remove & Replace Entire Ramp.
