Access Compliance Report

Public Rights-of-Way

(Curb Ramps)

Intersection ID: 15489	Main Street: HARVARD_PL	Cross Street: QUEENS_RD	Location: NE
ADA ID: A6853D9A51D1	Ramp Type: Perp	Initial Pass/Fail: Fail	Overall Compliance: No
Severity Score: 50			
Codes/Mitigation Info/Possible Solution		Field Measurements/Component Compliance

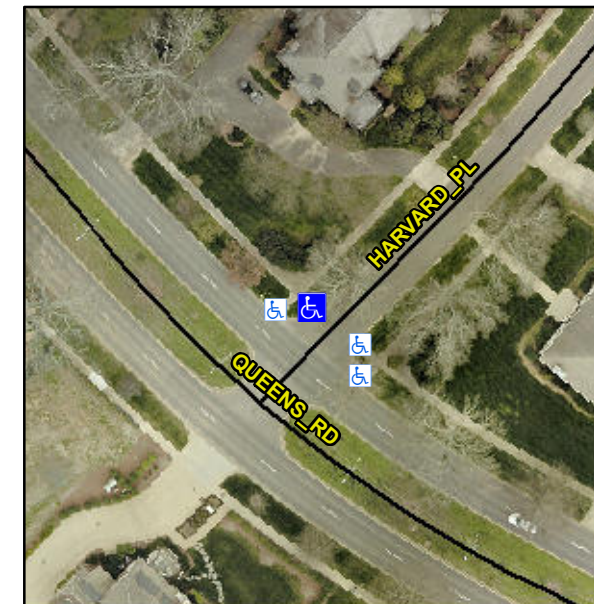
R304.2.2, R304.5.3

Compliance	Description	Data	Compliance	Description	Data
N/A	Ramp Length (in)	91.0	No	Ramp Slope (%)	13.6
Yes	Ramp Width (in)	58.0	No	Ramp XSlope (%)	8.3
N/A	Flare Type LT	N/A	N/A	Flare Type RT	N/A
N/A	Flare Slope LT (%)	N/A	N/A	Flare Slope RT (%)	N/A
N/A	Flare Traversable LT?	N/A	N/A	Flare Traversable RT?	N/A
N/A	Landing Length (in)	N/A	N/A	DWS Provided?	N/A
N/A	Landing Width (in)	N/A	N/A	DWS Contrast?	N/A
N/A	Landing Slope (%)	N/A	N/A	DWS Length (in)	N/A
N/A	Landing X Slope (%)	N/A	N/A	DWS Full Width?	N/A
N/A	Landing Curb? (Y/N)	N/A	N/A	DWS Offset (in)	N/A
N/A	Shared Landing?	N/A			
N/A	Gutter Ponding?	Yes	N/A	Gutter Slope (%)	N/A
N/A	Gutter Lip Ht (in)	N/A	N/A	Gutter X Slope (%)	N/A
N/A	Painted X Walk1?	No	N/A	Painted X Walk2?	N/A
	X Walk 1 Direction	To SE		X Walk 2 Direction	N/A
N/A	X Walk 1 Width (in)	N/A	N/A	X Walk 2 Width (in)	N/A
	X Walk 1 Slope (%)	1.1		X Walk 2 Slope (%)	N/A
	X Walk 1 X Slope (%)	3.0		X Walk 2 X Slope (%)	N/A

N/A	Ramp inside XWalk1?	N/A	N/A	Ramp inside XWalk2?	N/A
	Road Slope (%)	N/A	N/A	Clear Space?	N/A
	Road X Slope (%)	N/A	N/A	Clear Space to XWalk (in)	N/A
N/A	Any Obstructions?	N/A	N/A	Storm Grate/Utility Hazard?	N/A
	Obstruction Type			Storm Grate/Utility Type	
		N/A			N/A
		Yes		Surface Condition? (G/P)	Good

Remove & Replace Entire Ramp.

\$ 1850.00
