# Access Compliance Report

## Public Rights-of-Way

### (Curb Ramps)

Intersection ID: 42769	Main Street: ERWIN_RIDGE_AV	Cross Street: JEANETTE_CR	Location: SE
ADA ID: A691320D484C	Ramp Type: PerpDiag	Initial Pass/Fail: Fail	Overall Compliance: No
		Severity Score: 30

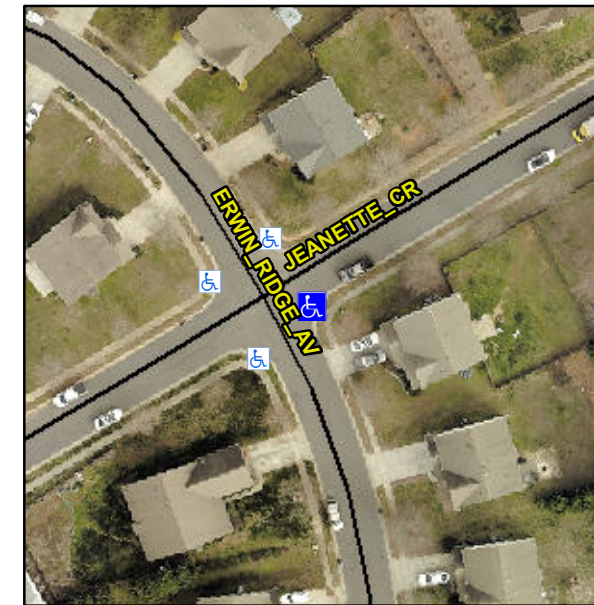
**Not Found, R304.5.1, R304.5.3**

Compliance	Description	Data	Compliance	Description	Data
N/A	Ramp Length (in)	52.0	Yes	Ramp Slope (%)	6.7
No	Ramp Width (in)	34.0	No	Ramp XSlope (%)	6.8
N/A	Flare Type LT	N/A	N/A	Flare Type RT	N/A
N/A	Flare Slope LT (%)	N/A	N/A	Flare Slope RT (%)	N/A
N/A	Flare Traversable LT?	N/A	N/A	Flare Traversable RT?	N/A
N/A	Landing Length (in)	N/A	N/A	DWS Provided?	N/A
N/A	Landing Width (in)	N/A	N/A	DWS Contrast?	N/A
N/A	Landing Slope (%)	N/A	N/A	DWS Length (in)	N/A
N/A	Landing X Slope (%)	N/A	N/A	DWS Full Width?	N/A
N/A	Landing Curb? (Y/N)	N/A	N/A	DWS Offset (in)	N/A
N/A	Shared Landing?	N/A			
N/A	Gutter Ponding?	N/A	N/A	Gutter Slope (%)	N/A
N/A	Gutter Lip Ht (in)	N/A	N/A	Gutter X Slope (%)	N/A
N/A	Painted X Walk1?	No	N/A	Painted X Walk2?	No
	X Walk 1 Direction	To N		X Walk 2 Direction	To W
N/A	X Walk 1 Width (in)	N/A	N/A	X Walk 2 Width (in)	N/A
	X Walk 1 Slope (%)	4.7		X Walk 2 Slope (%)	0.8
	X Walk 1 X Slope (%)	2.9		X Walk 2 X Slope (%)	7.9

N/A	Ramp inside XWalk1?	N/A	N/A	Ramp inside XWalk2?	N/A
	Road Slope (%)	8.1	N/A	Clear Space?	N/A
	Road X Slope (%)	4.8	N/A	Clear Space to XWalk (in)	N/A
N/A	Any Obstructions?	N/A	N/A	Storm Grate/Utility Hazard?	N/A
	Obstruction Type			Storm Grate/Utility Type	
		N/A			N/A
			Yes	Surface Condition? (G/P)	Good

**Remove & Replace Curb Ramp With Two New Directional Ramps or Equivalent.**

Total Cost: \$ 3200.00
