Access Compliance Report

Public Rights-of-Way

(Curb Ramps)

Intersection ID: 47816	Main Street: ROCKMOOR RIDGE RD	Cross Street: MISTY VIEW CT	Location: SW
ADA ID: A6958EA3BE19	Ramp Type: PerpDiag	Initial Pass/Fail: Pass	Overall Compliance: No
Severity Score: 12.5			
Codes/Mitigation Info/Possible Solution		Field Measurements/Component Compliance

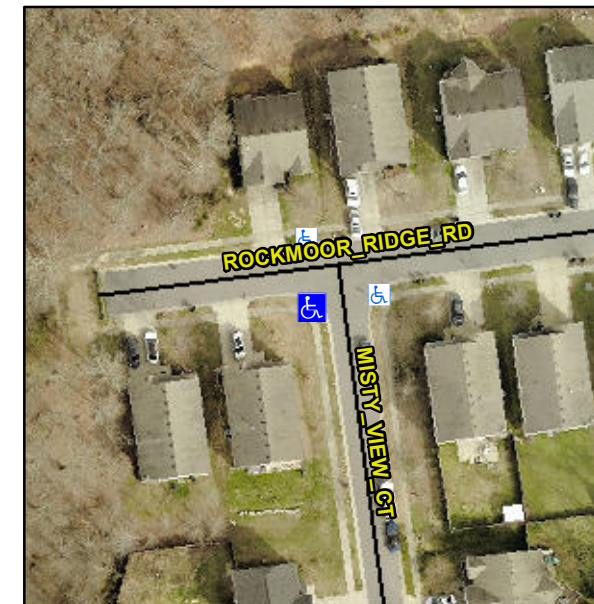
Not Found, R304.2.1, R302.7.2, R304.5.4, R304.5.3

Compliance	Description	Data	Compliance	Description	Data
N/A	Ramp Length (in)	42.5	Yes	Ramp Slope (%)	5.2
Yes	Ramp Width (in)	48.0	Yes	Ramp XSlope (%)	1.4
N/A	Flare Type LT	Sloped	N/A	Flare Type RT	N/A
N/A	Flare Slope LT (%)	0.6	N/A	Flare Slope RT (%)	0.0
N/A	Flare Traversable LT?	No	N/A	Flare Traversable RT?	No
Yes	Landing Length (in)	51.0	Yes	DWS Provided?	Yes
No	Landing Width (in)	38.0	Yes	DWS Contrast?	Yes
Yes	Landing Slope (%)	1.5	Yes	DWS Length (in)	24.0
Yes	Landing X Slope (%)	1.1	Yes	DWS Full Width?	Yes
N/A	Landing Curb? (Y/N)	No	Yes	DWS Offset (in)	1.0
N/A	Shared Landing?	No			
Yes	Gutter Ponding?	No	No	Gutter Slope (%)	7.1
No	Gutter Lip Ht (in)	0.5	No	Gutter X Slope (%)	2.5
N/A	Painted X Walk1?	No	N/A	Painted X Walk2?	No
	X Walk 1 Direction	To E		X Walk 2 Direction	To N
N/A	X Walk 1 Width (in)	N/A	N/A	X Walk 2 Width (in)	N/A
	X Walk 1 Slope (%)	2.2		X Walk 2 Slope (%)	2.6
	X Walk 1 X Slope (%)	2.8		X Walk 2 X Slope (%)	5.9

N/A	Ramp inside XWalk1?	N/A	N/A	Ramp inside XWalk2?	N/A
	Road Slope (%)	2.6	N/A	Clear Space?	Yes
	Road X Slope (%)	5.0	N/A	Clear Space to XWalk (in)	N/A
Yes	Any Obstructions?	No	Yes	Storm Grate/Utility Hazard?	No
	Obstruction Type			Storm Grate/Utility Type	
		N/A			N/A
		Yes		Surface Condition? (G/P)	Good

Remove & Replace Curb Ramp With Two New Directional Ramps or Equivalent. Remove & Replace Gutter.
