# Access Compliance Report

## Public Rights-of-Way

### (Curb Ramps)

| Intersection ID: 14225 | Main Street: N_CASWELL_RD | Cross Street: VAIL_AV | Location: SE |

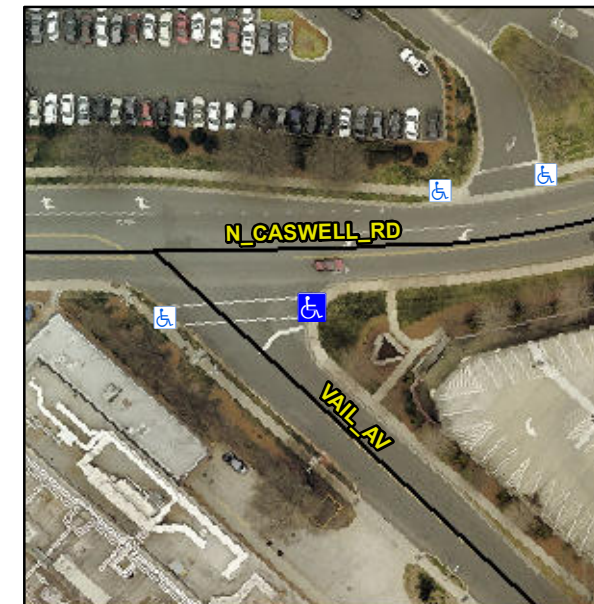
| ADA ID: A69693F8EA7D | Ramp Type: PerpDiag | Initial Pass/Fail: Fail | Overall Compliance: No |
| | | | Severity Score: 21.25 |

**Not Found, R304.5.1, R304.5.3**

| Compliance | Description | Data | Compliance | Description | Data |
|---|---|---|---|---|---|
| N/A | Ramp Length (in) | 57.0 | Yes | Ramp Slope (%) | 6.5 |
| No | Ramp Width (in) | 47.0 | No | Ramp XSlope (%) | 5.3 |

**Remove & Replace Curb Ramp With Two New Directional Ramps or Equivalent.**
