# Access Compliance Report

## Public Rights-of-Way (Curb Ramps)

| Intersection ID: 51721 | Main Street: PROVIDENCE_RD_WEST | Cross Street: BALLANCROFT_PY | Location: | NE |
| ADA ID: A6A0D3FB9EAA | Ramp Type: Directional1 | Initial Pass/Fail: Fail | Overall Compliance: No | Severity Score: 25 |

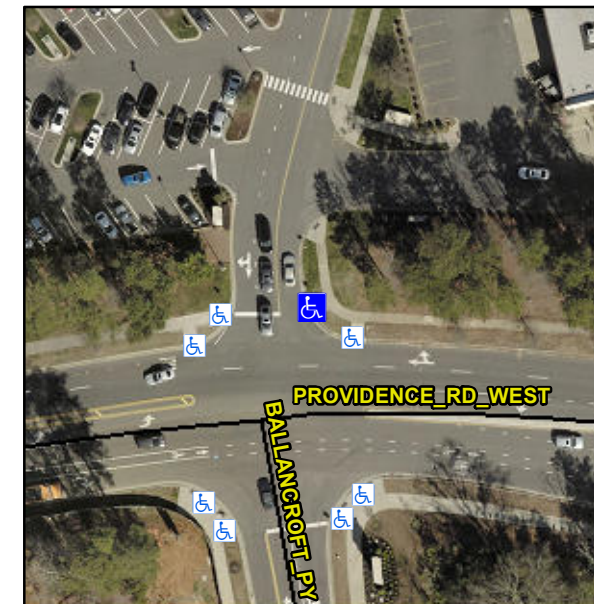
**R304.5.3**

| Compliance | Description | Data | Compliance | Description | Data |
|---|---|---|---|---|---|
| No | Ramp XSlope (%) | 8.6 | | | |

**Remove & Replace Entire Ramp.**

\$ 1600.00
