Access Compliance Report

Public Rights-of-Way

(Curb Ramps)

Intersection ID: 20146	Main Street: FAIRVIEW_RD	Cross Street: PARK_SOUTH_DR	Location: NE
ADA ID: A6A81EA7E8F3	Ramp Type: Para	Initial Pass/Fail: Pass	Overall Compliance: No
Severity Score: 0.25			
Codes/Mitigation Info/Possible Solution		Field Measurements/Component Compliance

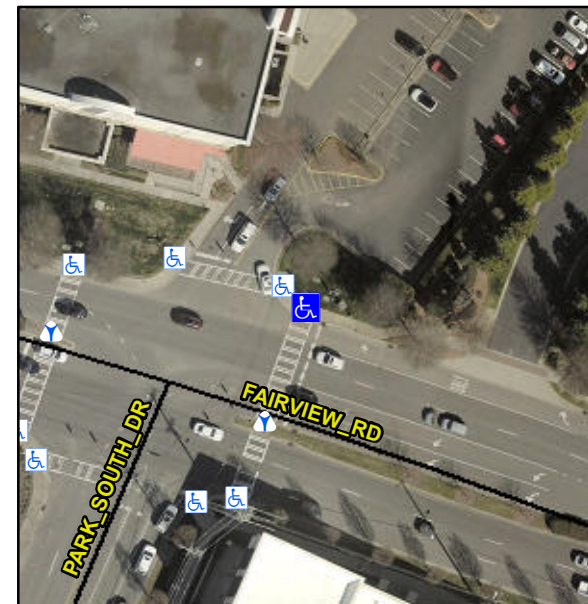
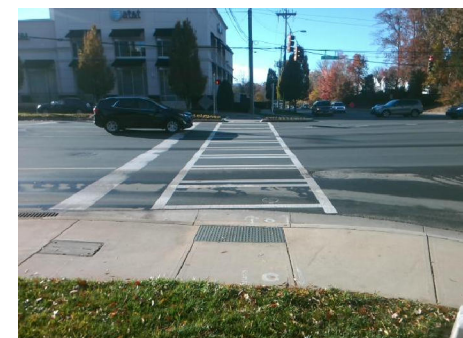
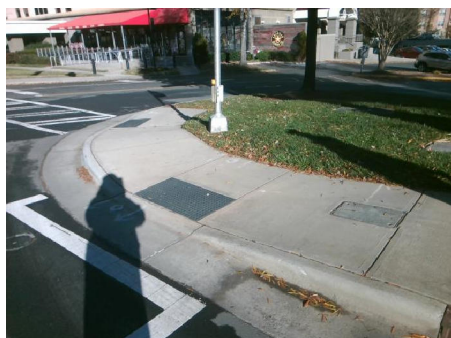
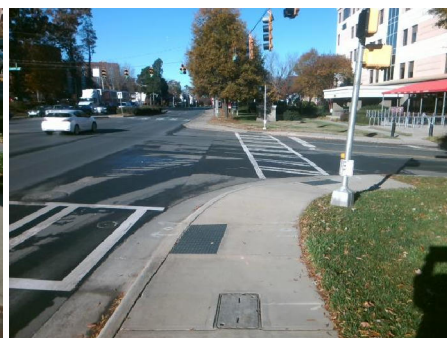
LT RP < 5%

Compliance	Description	Data	Compliance	Description	Data
N/A	Ramp Length LT (in)	62.0	N/A	Ramp Length RT (in)	68.0
Yes	Ramp Width LT (in)	72.0	Yes	Ramp Width RT (in)	72.0
Yes	Ramp Slope LT (%)	4.3	Yes	Ramp Slope RT (%)	6.3
No	Ramp XSlope LT (%)	2.5	No	Ramp XSlope RT (%)	3.5
Yes	Landing Length (in)	72.0	Yes	DWS Provided?	Yes
Yes	Landing Width (in)	48.0	Yes	DWS Contrast?	Yes
No	Landing Slope (%)	3.3	Yes	DWS Length (in)	25.0
Yes	Landing X Slope (%)	1.1	Yes	DWS Full Width?	Yes
N/A	Landing Curb? (Y/N)	No	Yes	DWS Offset (in)	0.0
N/A	Shared Landing?	No			
Yes	Gutter Ponding?	No	Yes	Gutter Slope (%)	3.5
Yes	Gutter Lip Ht (in)	0.0	Yes	Gutter X Slope (%)	1.0
N/A	Painted X Walk1?	Yes	N/A	Painted X Walk2?	N/A
	X Walk 1 Direction	To S		X Walk 2 Direction	N/A
N/A	X Walk 1 Width (in)	110.0	N/A	X Walk 2 Width (in)	N/A
	X Walk 1 Slope (%)	3.3		X Walk 2 Slope (%)	N/A
	X Walk 1 X Slope (%)	0.4		X Walk 2 X Slope (%)	N/A
Yes	Ramp inside XWalk1?	Yes	N/A	Ramp inside XWalk2?	N/A

Road Slope (%)	N/A	N/A	Clear Space?	Yes
	Road X Slope (%)	N/A	N/A	Clear Space to XWalk (in)	N/A
Yes	Any Obstructions?	No	Yes	Storm Grate/Utility Hazard?	No
	Obstruction Type			Storm Grate/Utility Type	
		N/A			N/A
			Yes	Surface Condition? (G/P)	Good
			N/A	Curb Slope (%)	5.2

Possible Solutions:

Remove & Replace Entire Ramp.

R304.5.3, R304.2.2-Perp, R304.3.2-Para
