Access Compliance Report

Public Rights-of-Way

(Curb Ramps)

Intersection ID: 10020348	Main Street: BALLANTYNE COMMONS PY	Cross Street: N/A	Location: SE
ADA ID: A6AD08C57DD2	Ramp Type: Perp	Initial Pass/Fail: Fail	Overall Compliance: No
Codes/Mitigation Info/Possible Solution		Field Measurements/Component Compliance	
Severity Score: 21.25

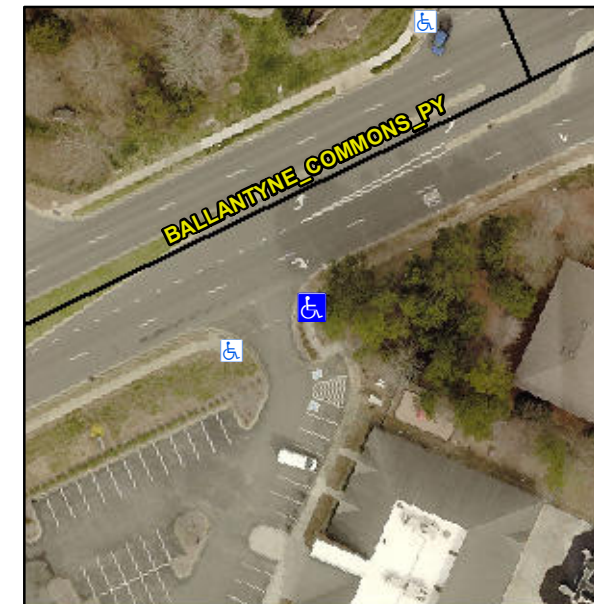
PROW/ADA:

Not Found, R304.5.1, R304.2.2

Compliance	Description	Data	Compliance	Description	Data
N/A	Ramp Length (in)	105.0	No	Ramp Slope (%)	8.6
No	Ramp Width (in)	36.0	Yes	Ramp XSlope (%)	0.3
N/A	Flare Type LT	N/A	N/A	Flare Type RT	N/A
N/A	Flare Slope LT (%)	N/A	N/A	Flare Slope RT (%)	N/A
N/A	Flare Traversable LT?	N/A	N/A	Flare Traversable RT?	N/A
N/A	Landing Length (in)	N/A	N/A	DWS Provided?	N/A
N/A	Landing Width (in)	N/A	N/A	DWS Contrast?	N/A
N/A	Landing Slope (%)	N/A	N/A	DWS Length (in)	N/A
N/A	Landing X Slope (%)	N/A	N/A	DWS Full Width?	N/A
N/A	Landing Curb? (Y/N)	N/A	N/A	DWS Offset (in)	N/A
N/A	Shared Landing?	N/A			
N/A	Gutter Ponding?	N/A	N/A	Gutter Slope (%)	N/A
N/A	Gutter Lip Ht (in)	N/A	N/A	Gutter X Slope (%)	N/A
N/A	Painted X Walk1?	No	N/A	Painted X Walk2?	N/A
	X Walk 1 Direction	To W		X Walk 2 Direction	N/A
N/A	X Walk 1 Width (in)	N/A	N/A	X Walk 2 Width (in)	N/A
	X Walk 1 Slope (%)	3.6		X Walk 2 Slope (%)	N/A
	X Walk 1 X Slope (%)	4.4		X Walk 2 X Slope (%)	N/A

N/A	Ramp inside XWalk1?	N/A	N/A	Ramp inside XWalk2?	N/A
	Road Slope (%)	N/A	N/A	Clear Space?	N/A
	Road X Slope (%)	N/A	N/A	Clear Space to XWalk (in)	N/A
N/A	Any Obstructions?	N/A	N/A	Storm Grate/Utility Hazard?	N/A
	Obstruction Type			Storm Grate/Utility Type	
		N/A			N/A
			Yes	Surface Condition? (G/P)	Good

Possible Solutions:

Remove & Replace Entire Ramp.
