# Access Compliance Report

## Public Rights-of-Way

### (Curb Ramps)

Intersection ID: 8289	Main Street: GRIER_RD	Cross Street: NEWELL_HICKORY_GROVE_RD	Location: W
ADA ID: A6B76DA93B39	Ramp Type: Perp	Initial Pass/Fail: Fail	Overall Compliance: No
Codes/Mitigation Info/Possible Solution		Field Measurements/Component Compliance	
Severity Score: 21.25

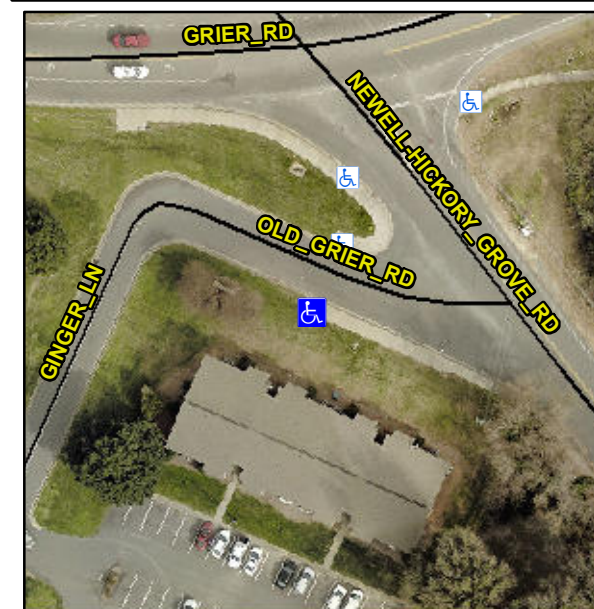
**Not Found, R304.5.1, R304.2.2**

Compliance	Description	Data	Compliance	Description	Data
N/A	Ramp Length (in)	84.0	No	Ramp Slope (%)	11.6
No	Ramp Width (in)	47.5	Yes	Ramp XSlope (%)	1.3
N/A	Flare Type LT	N/A	N/A	Flare Type RT	N/A
N/A	Flare Slope LT (%)	N/A	N/A	Flare Slope RT (%)	N/A
N/A	Flare Traversable LT?	N/A	N/A	Flare Traversable RT?	N/A
N/A	Landing Length (in)	N/A	N/A	DWS Provided?	N/A
N/A	Landing Width (in)	N/A	N/A	DWS Contrast?	N/A
N/A	Landing Slope (%)	N/A	N/A	DWS Length (in)	N/A
N/A	Landing X Slope (%)	N/A	N/A	DWS Full Width?	N/A
N/A	Landing Curb? (Y/N)	N/A	N/A	DWS Offset (in)	N/A
N/A	Shared Landing?	N/A			
N/A	Gutter Ponding?	N/A	N/A	Gutter Slope (%)	N/A
N/A	Gutter Lip Ht (in)	N/A	N/A	Gutter X Slope (%)	N/A
N/A	Painted X Walk1?	No	N/A	Painted X Walk2?	N/A
	X Walk 1 Direction	To NE		X Walk 2 Direction	N/A
N/A	X Walk 1 Width (in)	N/A	N/A	X Walk 2 Width (in)	N/A
	X Walk 1 Slope (%)	5.3		X Walk 2 Slope (%)	N/A
	X Walk 1 X Slope (%)	0.6		X Walk 2 X Slope (%)	N/A

N/A	Ramp inside XWalk1?	N/A	N/A	Ramp inside XWalk2?	N/A
	Road Slope (%)	N/A	N/A	Clear Space?	N/A
	Road X Slope (%)	N/A	N/A	Clear Space to XWalk (in)	N/A
N/A	Any Obstructions?	N/A	N/A	Storm Grate/Utility Hazard?	N/A
	Obstruction Type			Storm Grate/Utility Type	
		N/A			N/A
			Yes	Surface Condition? (G/P)	Good

**Remove & Replace Entire Ramp.**
