Access Compliance Report

Public Rights-of-Way

(Curb Ramps)

Intersection ID: 50602	Main Street: RHODORA_RD	Cross Street: CEDARFIELD_RD	Location: SE
ADA ID: A6C091520C38	Ramp Type: Perp	Initial Pass/Fail: Fail	Overall Compliance: No
			Severity Score: 33.75

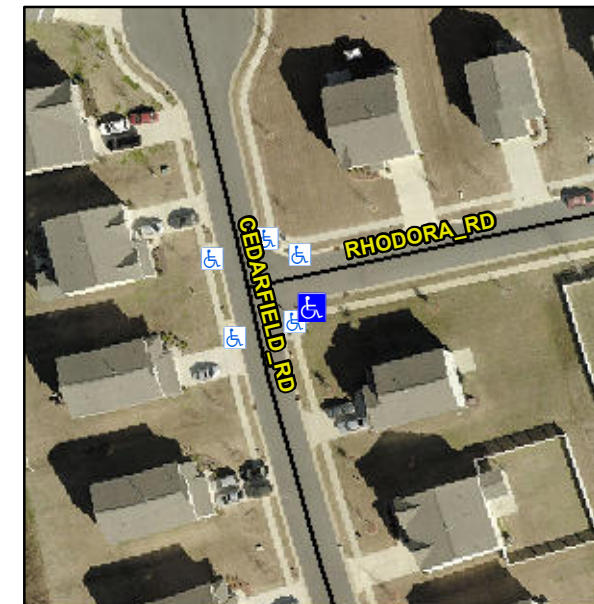
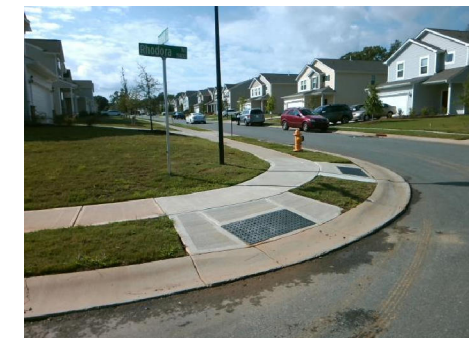
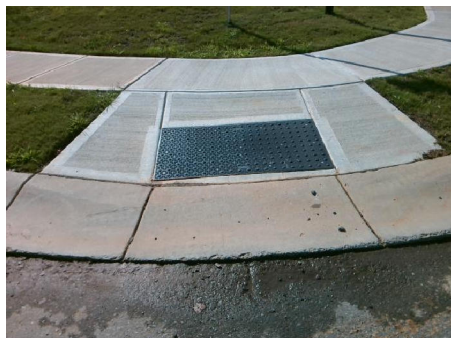
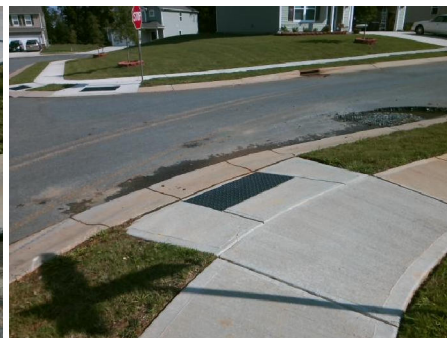
Not Found, R304.5.1, R304.2.2

Compliance	Description	Data	Compliance	Description	Data
N/A	Ramp Length (in)	48.0	No	Ramp Slope (%)	17.5
No	Ramp Width (in)	47.5	Yes	Ramp XSlope (%)	1.9
N/A	Flare Type LT	N/A	N/A	Flare Type RT	N/A
N/A	Flare Slope LT (%)	N/A	N/A	Flare Slope RT (%)	N/A
N/A	Flare Traversable LT?	N/A	N/A	Flare Traversable RT?	N/A
N/A	Landing Length (in)	N/A	N/A	DWS Provided?	N/A
N/A	Landing Width (in)	N/A	N/A	DWS Contrast?	N/A
N/A	Landing Slope (%)	N/A	N/A	DWS Length (in)	N/A
N/A	Landing X Slope (%)	N/A	N/A	DWS Full Width?	N/A
N/A	Landing Curb? (Y/N)	N/A	N/A	DWS Offset (in)	N/A
N/A	Shared Landing?	N/A			
N/A	Gutter Ponding?	N/A	N/A	Gutter Slope (%)	N/A
N/A	Gutter Lip Ht (in)	N/A	N/A	Gutter X Slope (%)	N/A
N/A	Painted X Walk1?	No	N/A	Painted X Walk2?	N/A
	X Walk 1 Direction	To N		X Walk 2 Direction	N/A
N/A	X Walk 1 Width (in)	N/A	N/A	X Walk 2 Width (in)	N/A
	X Walk 1 Slope (%)	0.8		X Walk 2 Slope (%)	N/A
	X Walk 1 X Slope (%)	0.1		X Walk 2 X Slope (%)	N/A

N/A	Ramp inside XWalk1?	N/A	N/A	Ramp inside XWalk2?	N/A
	Road Slope (%)	N/A	N/A	Clear Space?	N/A
	Road X Slope (%)	N/A	N/A	Clear Space to XWalk (in)	N/A
N/A	Any Obstructions?	N/A	N/A	Storm Grate/Utility Hazard?	N/A
	Obstruction Type			Storm Grate/Utility Type	
		N/A			N/A
			Yes	Surface Condition? (G/P)	Good

Remove & Replace Entire Ramp.
