Access Compliance Report

Public Rights-of-Way

(Curb Ramps)

Intersection ID: 9653	Main Street: EDISON_ST	Cross Street: WOODWARD_AV	Location: NW
ADA ID: A6C27B94D970	Ramp Type: ParaDiag	Initial Pass/Fail: Fail	Overall Compliance: No
			Severity Score: 13.75

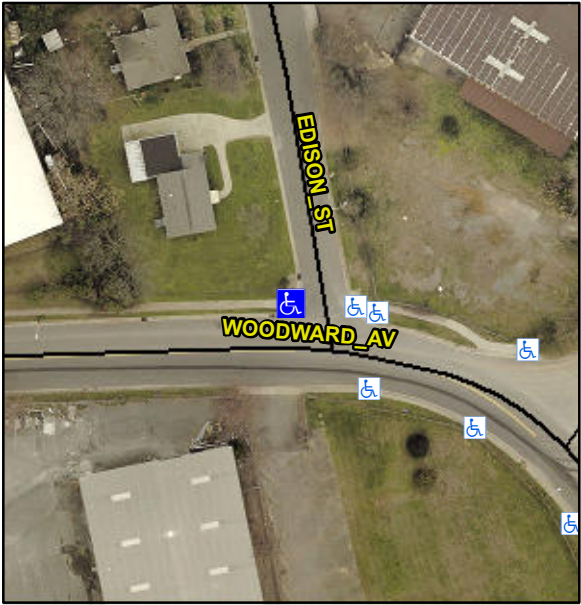
Possible Solutions:		Compliance	Description	Data
	Remove & Replace Curb Ramp With Two New Directional Ramps or Equivalent.		N/A	Ramp Length LT (in)	25.5
			Yes	Ramp Width LT (in)	75.5
			Yes	Ramp Slope LT (%)	1.1
			No	Ramp XSlope LT (%)	2.7
			N/A	Landing Length (in)	N/A
			N/A	Landing Width (in)	N/A
			N/A	Landing Slope (%)	N/A
			N/A	Landing X Slope (%)	N/A
			N/A	Landing Curb? (Y/N)	N/A
<p>Surveyor Notes:</p> <p>LT RP < 5%; CURB GAP 1.0</p> <p>PROW/ADA:</p> <p>R304.5.3, R304.3.2</p>			N/A	Ramp Length RT (in)	45.0
			Yes	Ramp Width RT (in)	60.0
			No	Ramp Slope RT (%)	11.7
			Yes	Ramp XSlope RT (%)	1.9
			N/A	DWS Provided?	N/A
			N/A	DWS Contrast?	N/A
			N/A	DWS Length (in)	N/A
			N/A	DWS Full Width?	N/A
			N/A	DWS Offset (in)	N/A
			N/A	Gutter Slope (%)	N/A
<p>Street 1 Name</p> <p>WOODWARD AV</p> <p>Stop Condition-Street 1</p> <p>None</p> <p>Street 2 Name</p> <p>EDISON ST</p> <p>Stop Condition-Street 2</p> <p>StopSign</p>			N/A	Gutter X Slope (%)	N/A

N/A	Gutter Lip Ht (in)	N/A
			N/A	Painted X Walk1?	No
				X Walk 1 Direction	To S
			N/A	X Walk 1 Width (in)	N/A
				X Walk 1 Slope (%)	2.8
				X Walk 1 X Slope (%)	4.7
			N/A	Ramp inside XWalk1?	N/A
				Road Slope (%)	4.7
				Road X Slope (%)	2.7
<p>Total Cost:</p> <p>\$ 3200.00</p>			N/A	Any Obstructions?	N/A
				Obstruction Type	
			N/A	Storm Grate/Utility Hazard?	N/A
				Storm Grate/Utility Type	
			N/A	Surface Condition? (G/P)	Good
			N/A	Curb Slope (%)	12.9
