# Access Compliance Report

## Public Rights-of-Way

### (Curb Ramps)

Intersection ID: 5104	Main Street: E_MALLARD_CREEK_CHURCH_RD	Cross Street: MARY_ALEXANDER_RD	Location: W
ADA ID: A6CA5C623056	Ramp Type: Perp	Initial Pass/Fail: Fail	Overall Compliance: No
Severity Score: 13.75			
Codes/Mitigation Info/Possible Solution		Field Measurements/Component Compliance

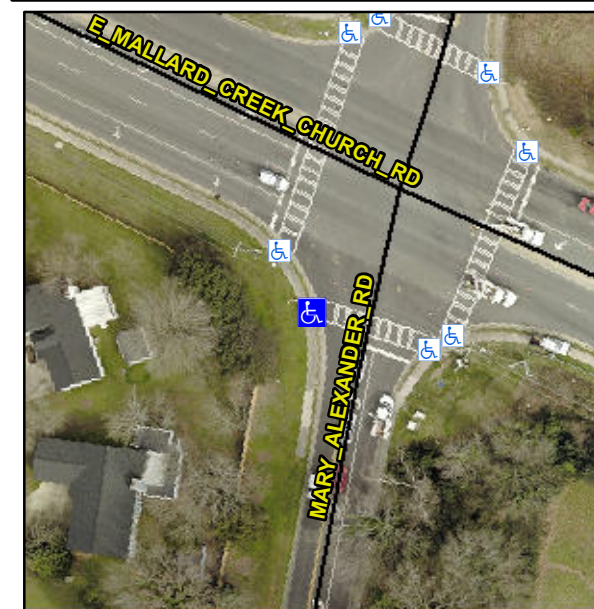
Compliance	Description	Data	Compliance	Description	Data
N/A	Ramp Length (in)	70.0	No	Ramp Slope (%)	10.0
Yes	Ramp Width (in)	48.0	Yes	Ramp XSlope (%)	4.5
N/A	Flare Type LT	N/A	N/A	Flare Type RT	N/A
N/A	Flare Slope LT (%)	N/A	N/A	Flare Slope RT (%)	N/A
N/A	Flare Traversable LT?	N/A	N/A	Flare Traversable RT?	N/A
N/A	Landing Length (in)	N/A	N/A	DWS Provided?	N/A
N/A	Landing Width (in)	N/A	N/A	DWS Contrast?	N/A
N/A	Landing Slope (%)	N/A	N/A	DWS Length (in)	N/A
N/A	Landing X Slope (%)	N/A	N/A	DWS Full Width?	N/A
N/A	Landing Curb? (Y/N)	N/A	N/A	DWS Offset (in)	N/A
N/A	Shared Landing?	N/A			
N/A	Gutter Ponding?	N/A	N/A	Gutter Slope (%)	N/A
N/A	Gutter Lip Ht (in)	N/A	N/A	Gutter X Slope (%)	N/A
N/A	Painted X Walk1?	Yes	N/A	Painted X Walk2?	N/A
	X Walk 1 Direction	To SE		X Walk 2 Direction	N/A
N/A	X Walk 1 Width (in)	99.0	N/A	X Walk 2 Width (in)	N/A
	X Walk 1 Slope (%)	5.3		X Walk 2 Slope (%)	N/A
	X Walk 1 X Slope (%)	8.5		X Walk 2 X Slope (%)	N/A

N/A	Ramp inside XWalk1?	Yes	N/A	Ramp inside XWalk2?	N/A
	Road Slope (%)	N/A	N/A	Clear Space?	N/A
	Road X Slope (%)	N/A	N/A	Clear Space to XWalk (in)	N/A
N/A	Any Obstructions?	N/A	N/A	Storm Grate/Utility Hazard?	N/A
	Obstruction Type			Storm Grate/Utility Type	
		N/A			N/A
		Yes		Surface Condition? (G/P)	Good

Possible Solutions:

**Remove & Replace Entire Ramp.**

**R304.2.2**

Total Cost: \$ 1850.00
