Access Compliance Report Public Rights-of-Way (Curb Ramps)

Intersection ID: 4014 Main Street: DAVIS_LAKE_PY **Cross Street: DOWNING CREEK DR** Location: **ADA ID: A6CB01DEF8DB** Ramp Type: Perp Initial Pass/Fail: Fail **Overall Compliance: No Severity Score:** 37.5

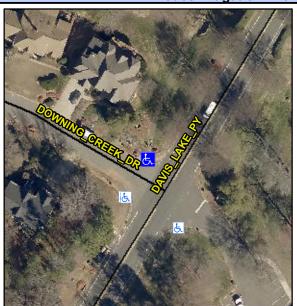
Field Measurements/Component Compliance					
Compliance Description		Data	Comp	oliance Description	Data
N/	A Ramp Length (in)	49.0	No	Ramp Slope (%)	13.4
Ye	s Ramp Width (in)	48.0	No	Ramp XSlope (%)	6.2
N/A	A Flare Type LT	N/A	N/A	Flare Type RT	N/A
N/	A Flare Slope LT (%)	N/A	N/A	Flare Slope RT (%)	N/A
N/	A Flare Traversable LT?	N/A	N/A	Flare Traversable RT?	N/A
N/	A Landing Length (in)	N/A	N/A	DWS Provided?	N/A
N/	A Landing Width (in)	N/A	N/A	DWS Contrast?	N/A
N/	A Landing Slope (%)	N/A	N/A	DWS Length (in)	N/A
N/	A Landing X Slope (%)	N/A	N/A	DWS Full Width?	N/A
N/	A Landing Curb? (Y/N)	N/A	N/A	DWS Offset (in)	N/A
N/	A Shared Landing?	N/A			
N/	A Gutter Ponding?	N/A	N/A	Gutter Slope (%)	N/A
N/A	A Gutter Lip Ht (in)	N/A	N/A	Gutter X Slope (%)	N/A
N/	A Painted X Walk1?	No	N/A	Painted X Walk2?	N/A
	X Walk 1 Direction	To SW		X Walk 2 Direction	N/A
N/	A X Walk 1 Width (in)	N/A	N/A	X Walk 2 Width (in)	N/A
	X Walk 1 Slope (%)	9.3		X Walk 2 Slope (%)	N/A

X Walk 1 X Slope (%)	1.3		X Walk 2 X Slope (%)	N/A
N/	A Ramp inside XWalk1?	N/A	N/A	Ramp inside XWalk2?	N/A
	Road Slope (%)	N/A	N/A	Clear Space?	N/A
	Road X Slope (%)	N/A	N/A	Clear Space to XWalk (in)	N/A
N/	A Any Obstructions?	N/A	N/A	Storm Grate/Utility Hazard?	N/A
	Obstruction Type			Storm Grate/Utility Type	
		N/A			N/A
			Yes	Surface Condition? (G/P)	Good

Possible Solutions: Remove & Replace Entire Ramp. Surveyor Notes: N/A PROW/ADA: Not Found, R304.2.2, R304.5.3
