# Access Compliance Report

## Public Rights-of-Way

### (Curb Ramps)

Intersection ID: 1002943	Main Street: CRAWFORD_BROOK_LN	Cross Street: N/A	Location: SE
ADA ID: A6DAE55DC93B	Ramp Type: BlendTrans1	Initial Pass/Fail: Fail	Overall Compliance: No
			Severity Score: 21.25

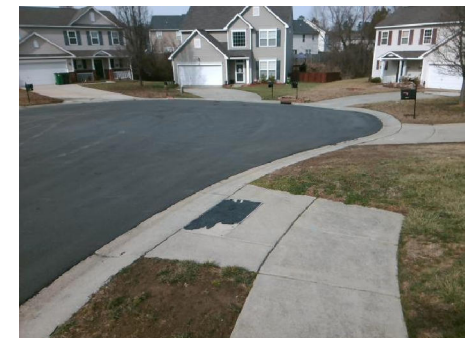
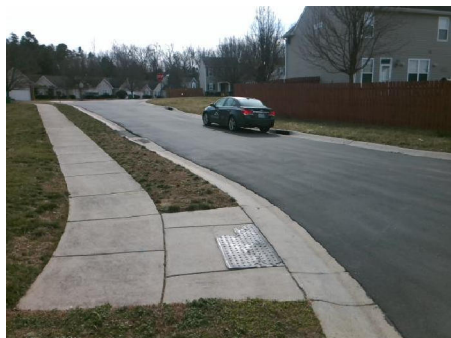
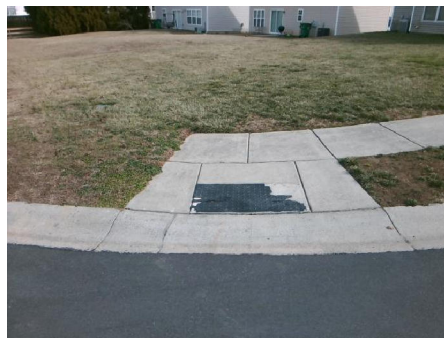
**DAMAGED DWS**

**Not Found, R304.5.1, R304.5.3**

Compliance	Description	Data	Compliance	Description	Data
N/A	Ramp Length (in)	48.0	Yes	BlendTrans Slope (%)	4.2
No	Ramp Width (in)	47.5	No	BlendTrans XSlope (%)	6.1
N/A	Flare Type LT	N/A	N/A	Flare Type RT	N/A
N/A	Flare Slope LT (%)	N/A	N/A	Flare Slope RT (%)	N/A
N/A	Flare Traversable LT?	N/A	N/A	Flare Traversable RT?	N/A
N/A	Landing Length (in)	N/A	N/A	DWS Provided?	N/A
N/A	Landing Width (in)	N/A	N/A	DWS Contrast?	N/A
N/A	Landing Slope (%)	N/A	N/A	DWS Length (in)	N/A
N/A	Landing X Slope (%)	N/A	N/A	DWS Full Width?	N/A
N/A	Landing Curb? (Y/N)	N/A	N/A	DWS Offset (in)	N/A
N/A	Shared Landing?	N/A			
N/A	Gutter Ponding?	N/A	N/A	Gutter Slope (%)	N/A
N/A	Gutter Lip Ht (in)	N/A	N/A	Gutter X Slope (%)	N/A
N/A	Painted X Walk1?	No	N/A	Painted X Walk2?	N/A
	X Walk 1 Direction	To W		X Walk 2 Direction	N/A
	X Walk 1 Width (in)	N/A		X Walk 2 Width (in)	N/A
	X Walk 1 Slope (%)	4.9		X Walk 2 Slope (%)	N/A
	X Walk 1 X Slope (%)	5.7		X Walk 2 X Slope (%)	N/A

N/A	Ramp inside XWalk1?	N/A	N/A	Ramp inside XWalk2?	N/A
	Road Slope (%)	5.7		Clear Space?	N/A
	Road X Slope (%)	4.9	N/A	Clear Space to XWalk (in)	N/A
N/A	Any Obstructions?	N/A	N/A	Storm Grate/Utility Hazard?	N/A
	Obstruction Type			Storm Grate/Utility Type	
		N/A			N/A
			Yes	Surface Condition? (G/P)	Good
			No	Curb Slope (%)	7.9

**Remove & Replace Curb Ramp With Two New Directional Ramps or Equivalent.**
