Access Compliance Report

Public Rights-of-Way

(Curb Ramps)

Intersection ID: 5967	Main Street: TRYON_ST	Cross Street: MCCULLOUGH_DR	Location: NE
ADA ID: A6DCD86BBBF8	Ramp Type: BlendTrans1	Initial Pass/Fail: Pass	Overall Compliance: No
Severity Score: 5			
Codes/Mitigation Info/Possible Solution		Field Measurements/Component Compliance

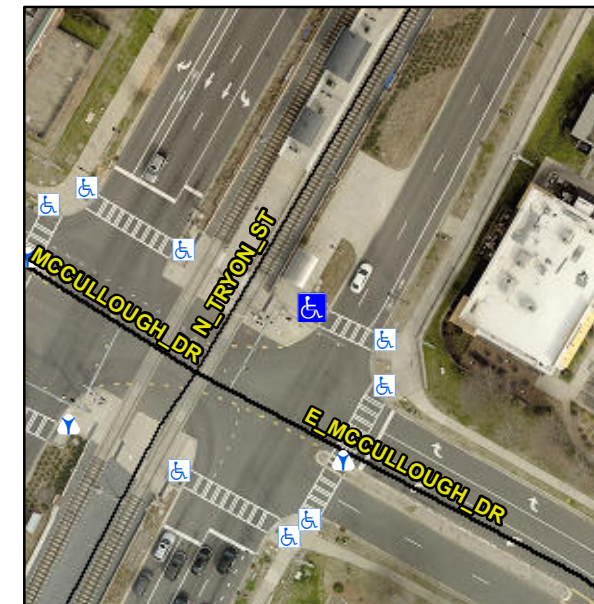
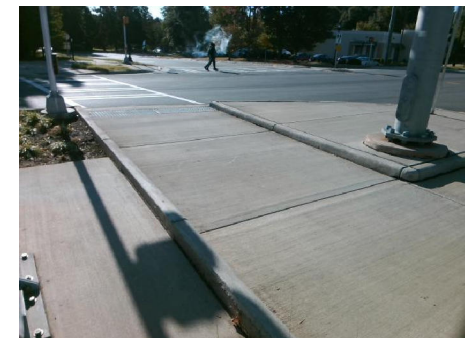
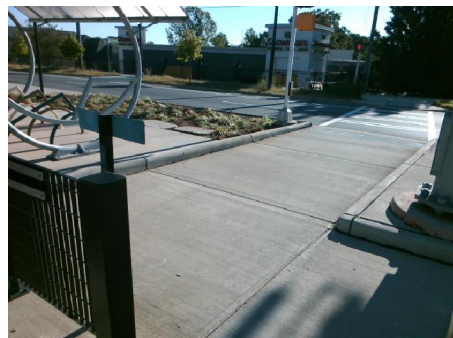
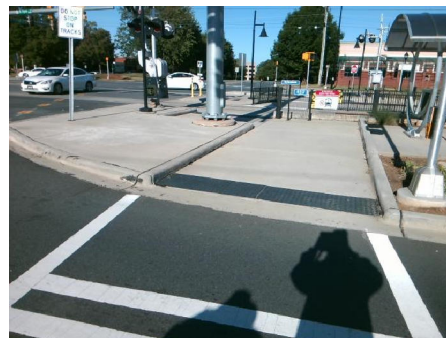
Compliance	Description	Data	Compliance	Description	Data
N/A	Ramp Length (in)	237.0	Yes	BlendTrans Slope (%)	0.1
Yes	Ramp Width (in)	120.5	Yes	BlendTrans XSlope (%)	1.4
No	Flare Type	Curbed_WithWalkSurface	Yes	Flare Type	Curbed_NoWalkSurface
N/A	Flare Slope LT (%)	N/A	N/A	Flare Slope RT (%)	N/A
N/A	Flare Traversable LT?	No	N/A	Flare Traversable RT?	No
Yes	Landing Length (in)	90.0	Yes	DWS Provided?	Yes
Yes	Landing Width (in)	120.5	Yes	DWS Contrast?	Yes
Yes	Landing Slope (%)	1.4	Yes	DWS Length (in)	24.0
Yes	Landing X Slope (%)	0.6	Yes	DWS Full Width?	Yes
N/A	Landing Curb? (Y/N)	No	No	DWS Offset (in)	3.0
N/A	Shared Landing?	Yes			
Yes	Gutter Ponding?	No	Yes	Gutter Slope (%)	2.5
Yes	Gutter Lip Ht (in)	0.0	Yes	Gutter X Slope (%)	2.0
N/A	Painted X Walk1?	Yes	N/A	Painted X Walk2?	N/A
	X Walk 1 Direction	To SE		X Walk 2 Direction	N/A
	X Walk 1 Width (in)	108.0		X Walk 2 Width (in)	N/A
	X Walk 1 Slope (%)	3.4		X Walk 2 Slope (%)	N/A

X Walk 1 X Slope (%)	1.6		X Walk 2 X Slope (%)	N/A
Yes	Ramp inside XWalk1?	Yes	N/A	Ramp inside XWalk2?	N/A
	Road Slope (%)	1.6		Clear Space?	Yes
	Road X Slope (%)	3.4	N/A	Clear Space to XWalk (in)	N/A
Yes	Any Obstructions?	No	Yes	Storm Grate/Utility Hazard?	No
	Obstruction Type			Storm Grate/Utility Type	
		N/A			N/A
			Yes	Surface Condition? (G/P)	Good
			Yes	Curb Slope (%)	3.1

Remove & Replace Curb Ramp With Two New Directional Ramps or Equivalent.

R304.2.3, R305.2
