Access Compliance Report

Public Rights-of-Way

(Curb Ramps)

Intersection ID: 47137	Main Street: DARLINGTON_RD	Cross Street: FIELDSTONE_MANOR_DR	Location:	N
ADA ID: A6E1AA573C74	Ramp Type: Perp	Initial Pass/Fail: Fail	Overall Compliance: No	Severity Score: 8.75
Codes/Mitigation Info/Possible Solution		Field Measurements/Component Compliance

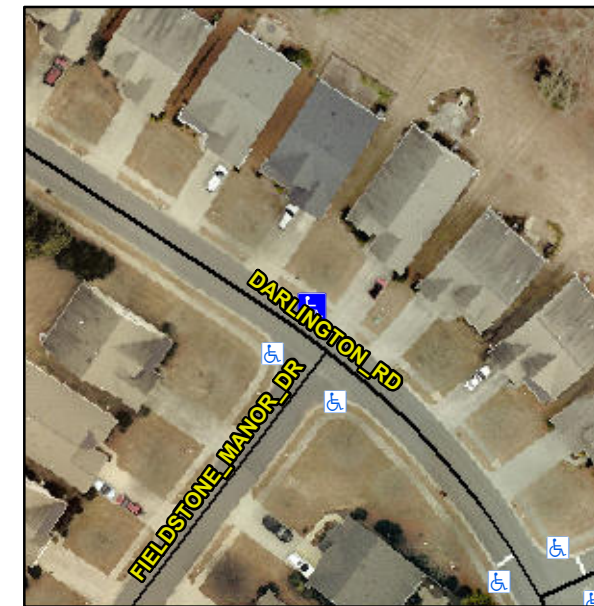
Not Found, R304.5.1

Compliance	Description	Data	Compliance	Description	Data
N/A	Ramp Length (in)	47.0	Yes	Ramp Slope (%)	7.7
No	Ramp Width (in)	44.0	Yes	Ramp XSlope (%)	1.0
N/A	Flare Type LT	N/A	N/A	Flare Type RT	N/A
N/A	Flare Slope LT (%)	N/A	N/A	Flare Slope RT (%)	N/A
N/A	Flare Traversable LT?	N/A	N/A	Flare Traversable RT?	N/A
N/A	Landing Length (in)	N/A	N/A	DWS Provided?	N/A
N/A	Landing Width (in)	N/A	N/A	DWS Contrast?	N/A
N/A	Landing Slope (%)	N/A	N/A	DWS Length (in)	N/A
N/A	Landing X Slope (%)	N/A	N/A	DWS Full Width?	N/A
N/A	Landing Curb? (Y/N)	N/A	N/A	DWS Offset (in)	N/A
N/A	Shared Landing?	N/A			
N/A	Gutter Ponding?	N/A	N/A	Gutter Slope (%)	N/A
N/A	Gutter Lip Ht (in)	N/A	N/A	Gutter X Slope (%)	N/A
N/A	Painted X Walk1?	No	N/A	Painted X Walk2?	N/A
	X Walk 1 Direction	To SW		X Walk 2 Direction	N/A
N/A	X Walk 1 Width (in)	N/A	N/A	X Walk 2 Width (in)	N/A
	X Walk 1 Slope (%)	2.1		X Walk 2 Slope (%)	N/A
	X Walk 1 X Slope (%)	0.5		X Walk 2 X Slope (%)	N/A

Remove & Replace Entire Ramp.
