Access Compliance Report Public Rights-of-Way (Curb Ramps)

Intersection ID: 43101 Main Street: E_9TH_ST Cross Street: PECAN_AV Location: NE

ADA ID: A6EBD9D98854 Ramp Type: PerpDiag Initial Pass/Fail: Fail Overall Compliance: No Severity Score: 12.5

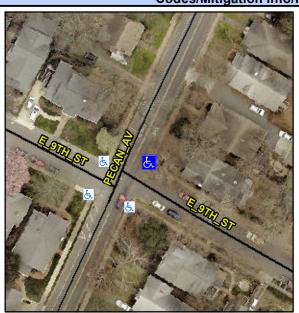
Fleid Measurements/Component Compilance					
Compliance Description		Data	Compliance Description		Data
N/A	Ramp Length (in)	102.0	No	Ramp Slope (%)	8.5
Yes	Ramp Width (in)	48.0	Yes	Ramp XSlope (%)	2.0
N/A	Flare Type LT	N/A	N/A	Flare Type RT	N/A
N/A	Flare Slope LT (%)	N/A	N/A	Flare Slope RT (%)	N/A
N/A	Flare Traversable LT?	N/A	N/A	Flare Traversable RT?	N/A
N/A	Landing Length (in)	N/A	N/A	DWS Provided?	N/A
N/A	Landing Width (in)	N/A	N/A	DWS Contrast?	N/A
N/A	Landing Slope (%)	N/A	N/A	DWS Length (in)	N/A
N/A	Landing X Slope (%)	N/A	N/A	DWS Full Width?	N/A
N/A	Landing Curb? (Y/N)	N/A	N/A	DWS Offset (in)	N/A
N/A	Shared Landing?	N/A			
N/A	Gutter Ponding?	N/A	N/A	Gutter Slope (%)	N/A
N/A	Gutter Lip Ht (in)	N/A	N/A	Gutter X Slope (%)	N/A
N/A	Painted X Walk1?	No	N/A	Painted X Walk2?	No
	X Walk 1 Direction	To NW		X Walk 2 Direction	To SW
N/A	X Walk 1 Width (in)	N/A	N/A	X Walk 2 Width (in)	N/A
	X Walk 1 Slope (%)	4.7		X Walk 2 Slope (%)	3.6

X Walk 1 X Slope (%)	0.9		X Walk 2 X Slope (%)	3.2
N/A	Ramp inside XWalk1?	N/A	N/A	Ramp inside XWalk2?	N/A
	Road Slope (%)	0.1	N/A	Clear Space?	N/A
	Road X Slope (%)	7.6	N/A	Clear Space to XWalk (in)	N/A
N/A	Any Obstructions?	N/A	N/A	Storm Grate/Utility Hazard?	N/A
	Obstruction Type		l	Storm Grate/Utility Type	
		N/A			N/A
			Yes	Surface Condition? (G/P)	Good
1 1 1 1 1 1 1 1 1 1 1 1 1 1 1 1 1 1 1		'	•	. ,

Remove & Replace Curb Ramp With
Two New Directional Ramps or
Equivalent.

R304.2.2
