# Access Compliance Report

## Public Rights-of-Way

### (Curb Ramps)

Intersection ID: 26825	Main Street: OAK_POND_CR	Cross Street: SUMMERSTON_PL	Location: SW
ADA ID: A6F4E45503D7	Ramp Type: PerpDiag	Initial Pass/Fail: Fail	Overall Compliance: No
Severity Score: 37.5			
Codes/Mitigation Info/Possible Solution		Field Measurements/Component Compliance

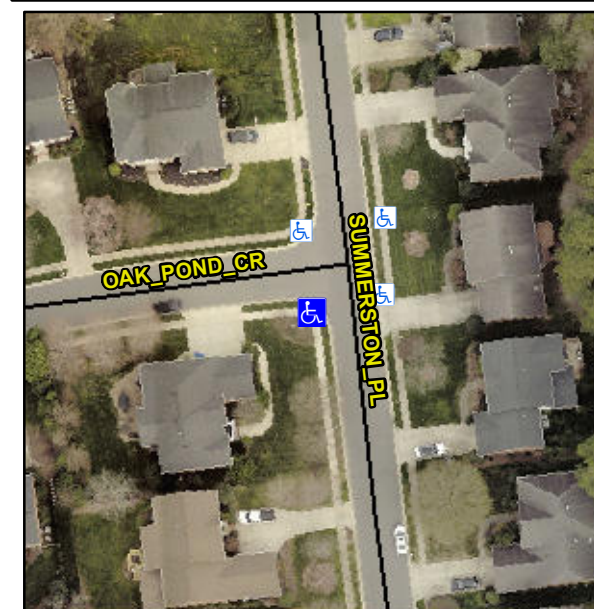
Compliance	Description	Data	Compliance	Description	Data
N/A	Ramp Length (in)	46.0	No	Ramp Slope (%)	10.5
Yes	Ramp Width (in)	97.5	No	Ramp XSlope (%)	8.4
N/A	Flare Type LT	N/A	N/A	Flare Type RT	N/A
N/A	Flare Slope LT (%)	N/A	N/A	Flare Slope RT (%)	N/A
N/A	Flare Traversable LT?	N/A	N/A	Flare Traversable RT?	N/A
N/A	Landing Length (in)	N/A	N/A	DWS Provided?	N/A
N/A	Landing Width (in)	N/A	N/A	DWS Contrast?	N/A
N/A	Landing Slope (%)	N/A	N/A	DWS Length (in)	N/A
N/A	Landing X Slope (%)	N/A	N/A	DWS Full Width?	N/A
N/A	Landing Curb? (Y/N)	N/A	N/A	DWS Offset (in)	N/A
N/A	Shared Landing?	N/A			
N/A	Gutter Ponding?	N/A	N/A	Gutter Slope (%)	N/A
N/A	Gutter Lip Ht (in)	N/A	N/A	Gutter X Slope (%)	N/A
N/A	Painted X Walk1?	No	N/A	Painted X Walk2?	No
	X Walk 1 Direction	To NE		X Walk 2 Direction	To N
N/A	X Walk 1 Width (in)	N/A	N/A	X Walk 2 Width (in)	N/A
	X Walk 1 Slope (%)	2.6		X Walk 2 Slope (%)	3.0
	X Walk 1 X Slope (%)	5.2		X Walk 2 X Slope (%)	2.7

N/A	Ramp inside XWalk1?	N/A	N/A	Ramp inside XWalk2?	N/A
	Road Slope (%)	6.6	N/A	Clear Space?	N/A
	Road X Slope (%)	1.8	N/A	Clear Space to XWalk (in)	N/A
N/A	Any Obstructions?	N/A	N/A	Storm Grate/Utility Hazard?	N/A
	Obstruction Type			Storm Grate/Utility Type	
		N/A			N/A
		Yes		Surface Condition? (G/P)	Good

Possible Solutions:

**Remove & Replace Curb Ramp With Two New Directional Ramps or Equivalent.**

**R304.2.2, R304.5.3**
