Access Compliance Report

Public Rights-of-Way

(Curb Ramps)

Intersection ID: 10036977	Main Street: S_TRYON_ST	Cross Street: N/A	Location: N
ADA ID: A6F75652A198	Ramp Type: Directional1	Initial Pass/Fail: Fail	Overall Compliance: No
Severity Score: 1.25			
Codes/Mitigation Info/Possible Solution		Field Measurements/Component Compliance

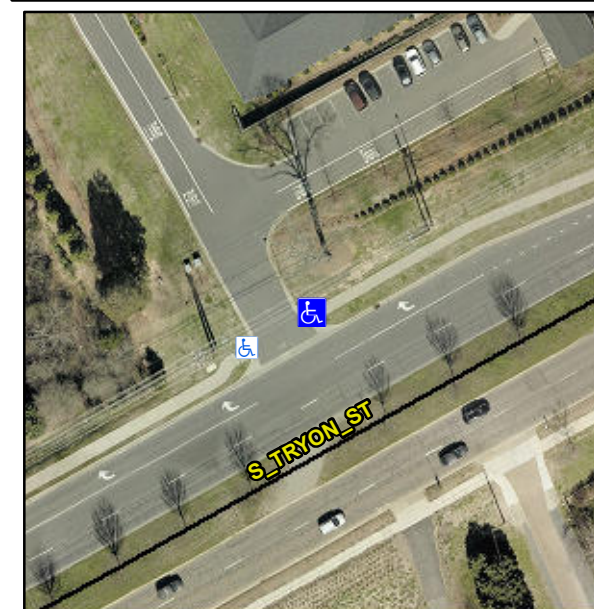
R304.5.3

Compliance	Description	Data	Compliance	Description	Data
N/A	Ramp Length (in)	80.0	N/A	Grade Break?	N/A
Yes	Ramp Width (in)	69.0	N/A	Grade Break Slope (%)	0.0
Yes	Ramp Slope (%)	3.8	N/A	Grade Break XSlope (%)	0.0
No	Ramp XSlope (%)	2.9			
N/A	Flare Type LT	N/A	N/A	Flare Type RT	N/A
N/A	Flare Slope LT (%)	N/A	N/A	Flare Slope RT (%)	0.0
N/A	Flare Traversable LT?	N/A	N/A	Flare Traversable RT?	N/A
N/A	Landing Length (in)	0.0	N/A	DWS Provided?	N/A
N/A	Landing Width (in)	0.0	N/A	DWS Contrast?	N/A
N/A	Landing Slope (%)	0.0	N/A	DWS Length (in)	N/A
N/A	Landing X Slope (%)	0.0	N/A	DWS Full Width?	N/A
N/A	Landing Curb? (Y/N)	N/A	N/A	DWS Offset LT (in)	N/A
N/A	Shared Landing?	N/A	N/A	DWS Offset RT (in)	N/A
N/A	Gutter Ponding?	0.0	N/A	Gutter Slope (%)	N/A
N/A	Gutter Lip Ht (in)	0.0	N/A	Gutter X Slope (%)	N/A
N/A	Painted X Walk1?	No		Road Slope (%)	3.5
	X Walk 1 Direction	To SW		Road X Slope (%)	4.0
	X Walk 1 Width (in)	N/A		Clear Space?	N/A

X Walk 1 Slope (%)	3.5	N/A	Clear Space to XWalk (in)	N/A
	X Walk 1 X Slope (%)	4.0	N/A	Storm Grate/Utility Hazard?	N/A
N/A	Ramp inside XWalk1?	N/A		Storm Grate/Utility Type	
N/A	Any Obstructions?	N/A			N/A
	Obstruction Type		Yes	Surface Condition? (G/P)	Good
			N/A	Curb Slope (%)	4.3

Possible Solutions:

Remove & Replace Entire Ramp.

Total Cost: \$ 1600.00
