Access Compliance Report

Public Rights-of-Way

(Curb Ramps)

Intersection ID: 10032958		Main Street: NEW RENAISSANCE_WY	Cross Street: N/A	Location:	SW
ADA ID: A6F7B3A04F78		Ramp Type: Directional1	Initial Pass/Fail: Fail	Overall Compliance: No	Severity Score: 1.25
Codes/Mitigation Info/Possible Solution			Field Measurements/Component Compliance

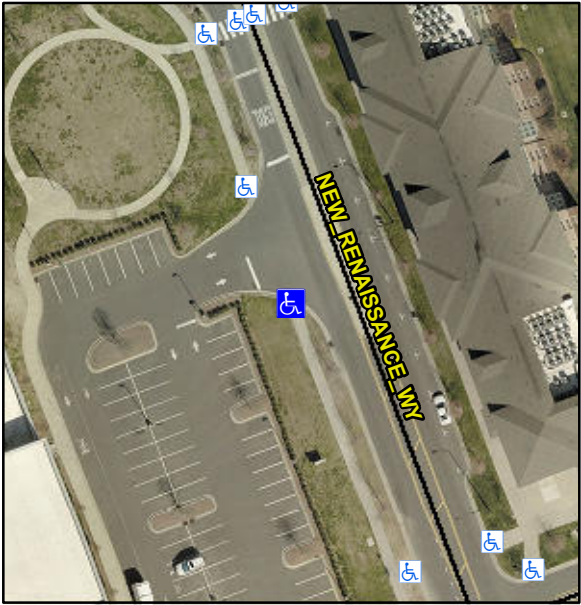
Possible Solutions:		Compliance	Description	Data
	Remove & Replace Entire Ramp.		N/A	Ramp Length (in)	52.0
			Yes	Ramp Width (in)	72.0
			Yes	Ramp Slope (%)	1.9
			No	Ramp XSlope (%)	3.6
			N/A	Flare Type LT	N/A
			N/A	Flare Slope LT (%)	N/A
			N/A	Flare Traversable LT?	N/A
			N/A	Landing Length (in)	0.0
			N/A	Landing Width (in)	0.0
Surveyor Notes:		Compliance	Description	Data	
N/A		N/A	Flare Slope RT (%)	N/A	0.0
		N/A	Flare Traversable RT?	N/A	N/A
		N/A	DWS Provided?	N/A	N/A
		N/A	DWS Contrast?	N/A	N/A
		N/A	DWS Length (in)	N/A	N/A
		N/A	DWS Full Width?	N/A	N/A
		N/A	DWS Offset LT (in)	N/A	N/A
		N/A	DWS Offset RT (in)	N/A	N/A

N/A	Gutter Slope (%)	N/A	N/A
		N/A	Gutter X Slope (%)	N/A	N/A
		N/A	Road Slope (%)	2.6	
		N/A	Road X Slope (%)	2.4	
		N/A	Clear Space?	N/A	
		N/A	Clear Space to XWalk (in)	N/A	
		N/A	Storm Grate/Utility Hazard?	N/A	
		N/A	Storm Grate/Utility Type		
		N/A	Surface Condition? (G/P)	Good	
		N/A	Curb Slope (%)	5.4	
PROW/ADA:					
R304.5.3					
Total Cost:		\$	1600.00		
Street 1 Name	ENTRANCE				
Stop Condition-Street 1	StopSign				
Street 2 Name	N/A				
Stop Condition-Street 2	N/A
