# Access Compliance Report

## Public Rights-of-Way

### (Curb Ramps)

| Intersection ID: 9076 | Main Street: STATESVILLE_AV | Cross Street: MORETZ_AV | Location: NE |

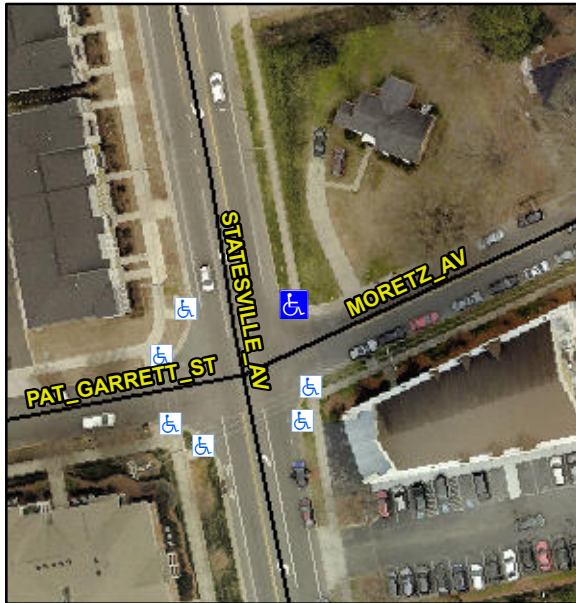
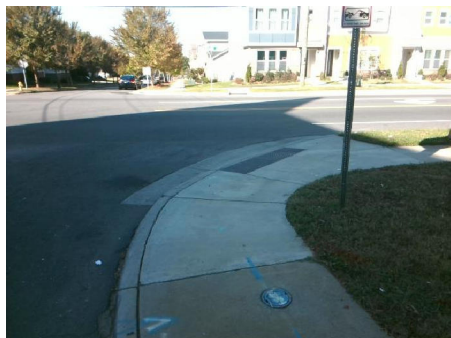
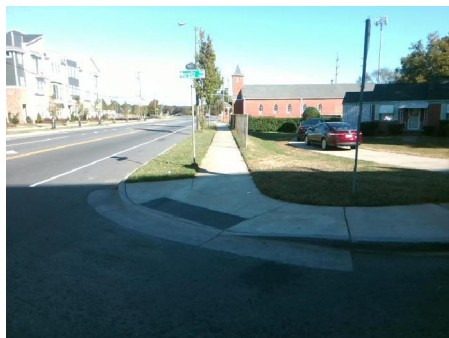
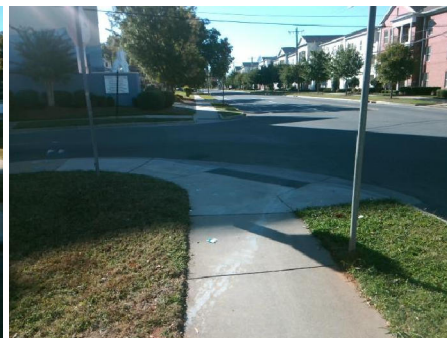
| ADA ID: A6FDA9530897 | Ramp Type: PerpDiag | Initial Pass/Fail: Pass | Overall Compliance: No |

**Not Found, R304.2.1, R304.2.2-Perp, R304.3.2-Para, R304.5.3, R305.2**

| Compliance | Description | Data | Compliance | Description | Data |
|---|---|---|---|---|---|
| No | Landing Length (in) | N/A | Yes | DWS Provided? | Yes |
| No | Landing Width (in) | N/A | Yes | DWS Contrast? | Yes |
| No | Landing Slope (%) | N/A | Yes | DWS Length (in) | 24.0 |
| No | Landing X Slope (%) | N/A | Yes | DWS Full Width? | Yes |
| N/A | Landing Curb? (Y/N) | No | No | DWS Offset (in) | 5.0 |

**Remove & Replace Curb Ramp With Two New Directional Ramps or Equivalent.**

Total Cost: \$ **3200.00**
