# Access Compliance Report

## Public Rights-of-Way

### (Curb Ramps)

| Intersection ID: 10036062 | Main Street: RIVERGATE_PY | Cross Street: N/A | Location: SW |

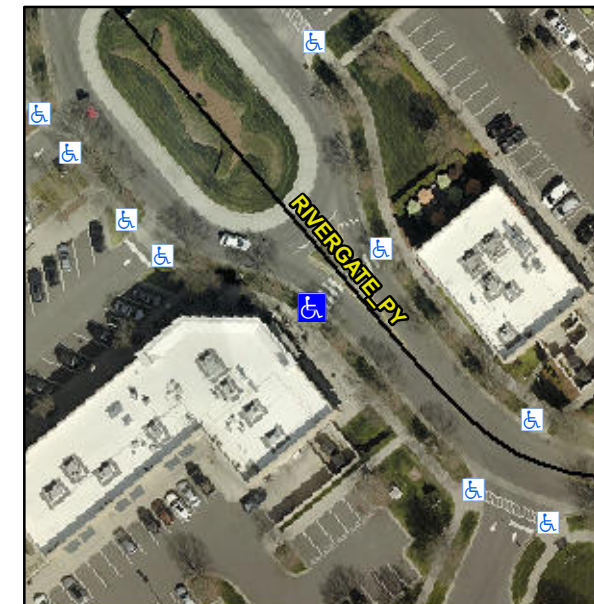
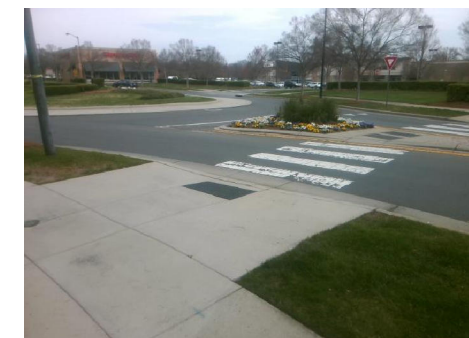
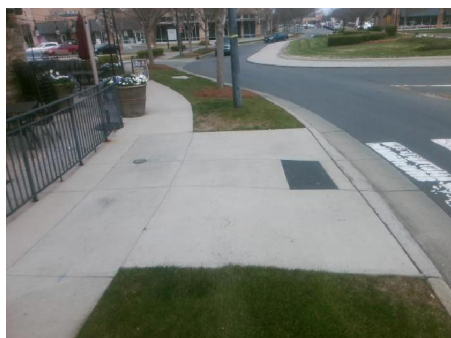
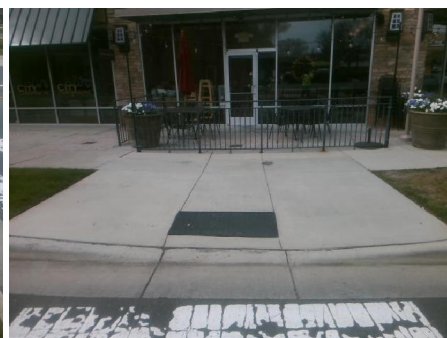
| ADA ID: A7020E028AE7 | Ramp Type: Perp | Initial Pass/Fail: Fail | Overall Compliance: No |
| Severity Score: 10 | | | |

**Not Found, R304.5.1, R304.5.3**

| Compliance | Description | Data | Compliance | Description | Data |
|---|---|---|---|---|---|
| No | Ramp Width (in) | 41.0 | No | Ramp XSlope (%) | 4.8 |

Possible Solutions:

**Remove & Replace Entire Ramp.**

Total Cost: \$ 1850.00
