Intersection ID: 3735	Main Street: DAVIS_LAKE_PY	Cross Street: FOXBRIAR_TL	Location:	SW
ADA ID: A7032029B681	Ramp Type: Perp	Initial Pass/Fail: Fail	Overall Compliance: No	Severity Score: 30

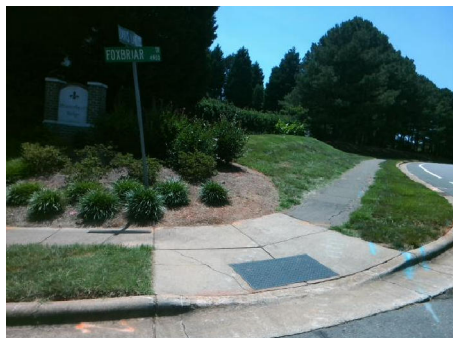
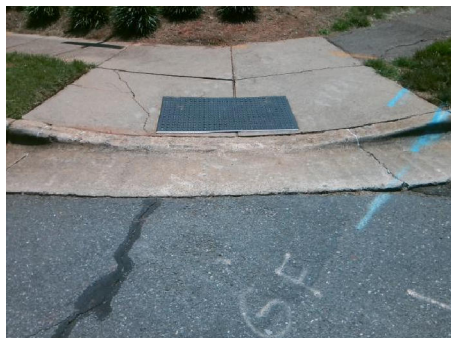
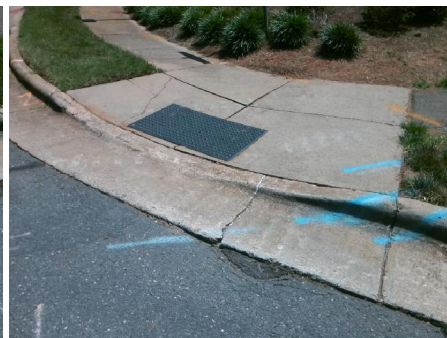
Possible Solutions:							
	Remove & Replace Entire Ramp.							
	Surveyor Notes:							
	N/A							
	PROW/ADA:							
	Not Found, R304.5.1, R304.5.3							
	Street 1 Name		FOXBRIR TR					
	Stop Condition-Street 2		StopSign					
	Street 2 Name		N/A					
	Stop Condition-Street 1		N/A					
Total Cost:		\$ 1850.00						
			Compliance	Description	Data	Compliance	Description	Data
			N/A	Ramp Length (in)	44.5	Yes	Ramp Slope (%)	6.5
			No	Ramp Width (in)	32.0	No	Ramp XSlope (%)	6.0
			N/A	Flare Type LT	N/A	N/A	Flare Type RT	N/A
			N/A	Flare Slope LT (%)	N/A	N/A	Flare Slope RT (%)	N/A
			N/A	Flare Traversable LT?	N/A	N/A	Flare Traversable RT?	N/A
			N/A	Landing Length (in)	N/A	N/A	DWS Provided?	N/A
			N/A	Landing Width (in)	N/A	N/A	DWS Contrast?	N/A
			N/A	Landing Slope (%)	N/A	N/A	DWS Length (in)	N/A
			N/A	Landing X Slope (%)	N/A	N/A	DWS Full Width?	N/A

N/A	Landing Curb? (Y/N)	N/A	N/A	DWS Offset (in)	N/A
			N/A	Shared Landing?	N/A			
			N/A	Gutter Ponding?	N/A	N/A	Gutter Slope (%)	N/A
			N/A	Gutter Lip Ht (in)	N/A	N/A	Gutter X Slope (%)	N/A
			N/A	Painted X Walk1?	No	N/A	Painted X Walk2?	N/A
				X Walk 1 Direction	To E		X Walk 2 Direction	N/A
			N/A	X Walk 1 Width (in)	N/A	N/A	X Walk 2 Width (in)	N/A
				X Walk 1 Slope (%)	4.0		X Walk 2 Slope (%)	N/A
				X Walk 1 X Slope (%)	8.1		X Walk 2 X Slope (%)	N/A
			N/A	Ramp inside XWalk1?	N/A	N/A	Ramp inside XWalk2?	N/A
				Road Slope (%)	N/A	N/A	Clear Space?	N/A
				Road X Slope (%)	N/A	N/A	Clear Space to XWalk (in)	N/A
			N/A	Any Obstructions?	N/A	N/A	Storm Grate/Utility Hazard?	N/A
				Obstruction Type			Storm Grate/Utility Type	
					N/A			N/A
						Yes	Surface Condition? (G/P)	Good
