Access Compliance Report

Public Rights-of-Way

(Curb Ramps)

Intersection ID: 5713	Main Street: RIDGE_ACRES_RD	Cross Street: TRAILING_ROCK_DR	Location:	N
ADA ID: A708DCD188F2	Ramp Type: Perp	Initial Pass/Fail: Fail	Overall Compliance: No	Severity Score: 10
Codes/Mitigation Info/Possible Solution		Field Measurements/Component Compliance

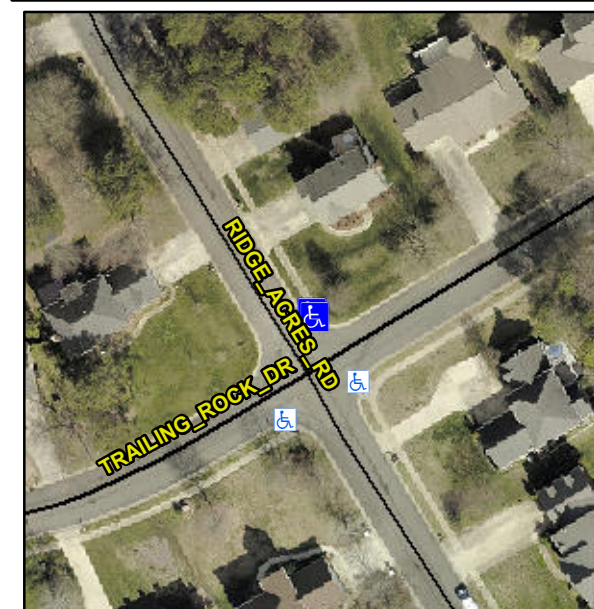
Not Found, R304.5.1, R304.5.3

Compliance	Description	Data	Compliance	Description	Data
N/A	Ramp Length (in)	36.0	Yes	Ramp Slope (%)	6.7
No	Ramp Width (in)	47.5	No	Ramp XSlope (%)	2.1
N/A	Flare Type LT	N/A	N/A	Flare Type RT	N/A
N/A	Flare Slope LT (%)	N/A	N/A	Flare Slope RT (%)	N/A
N/A	Flare Traversable LT?	N/A	N/A	Flare Traversable RT?	N/A
N/A	Landing Length (in)	N/A	N/A	DWS Provided?	N/A
N/A	Landing Width (in)	N/A	N/A	DWS Contrast?	N/A
N/A	Landing Slope (%)	N/A	N/A	DWS Length (in)	N/A
N/A	Landing X Slope (%)	N/A	N/A	DWS Full Width?	N/A
N/A	Landing Curb? (Y/N)	N/A	N/A	DWS Offset (in)	N/A
N/A	Shared Landing?	N/A			
N/A	Gutter Ponding?	N/A	N/A	Gutter Slope (%)	N/A
N/A	Gutter Lip Ht (in)	N/A	N/A	Gutter X Slope (%)	N/A
N/A	Painted X Walk1?	No	N/A	Painted X Walk2?	N/A
	X Walk 1 Direction	To S		X Walk 2 Direction	N/A
N/A	X Walk 1 Width (in)	N/A	N/A	X Walk 2 Width (in)	N/A
	X Walk 1 Slope (%)	1.2		X Walk 2 Slope (%)	N/A
	X Walk 1 X Slope (%)	3.7		X Walk 2 X Slope (%)	N/A

N/A	Ramp inside XWalk1?	N/A	N/A	Ramp inside XWalk2?	N/A
	Road Slope (%)	N/A	N/A	Clear Space?	N/A
	Road X Slope (%)	N/A	N/A	Clear Space to XWalk (in)	N/A
N/A	Any Obstructions?	N/A	N/A	Storm Grate/Utility Hazard?	N/A
	Obstruction Type			Storm Grate/Utility Type	
		N/A			N/A
			Yes	Surface Condition? (G/P)	Good

Possible Solutions:

Remove & Replace Entire Ramp.
