Access Compliance Report

Public Rights-of-Way

(Curb Ramps)

Intersection ID: N/A	Main Street: E_TRADE_ST	Cross Street: N/A	Location: NW
ADA ID: A70A4FD54B72	Ramp Type: Perp	Initial Pass/Fail: Pass	Overall Compliance: No
Severity Score: 5.25			
Codes/Mitigation Info/Possible Solution		Field Measurements/Component Compliance

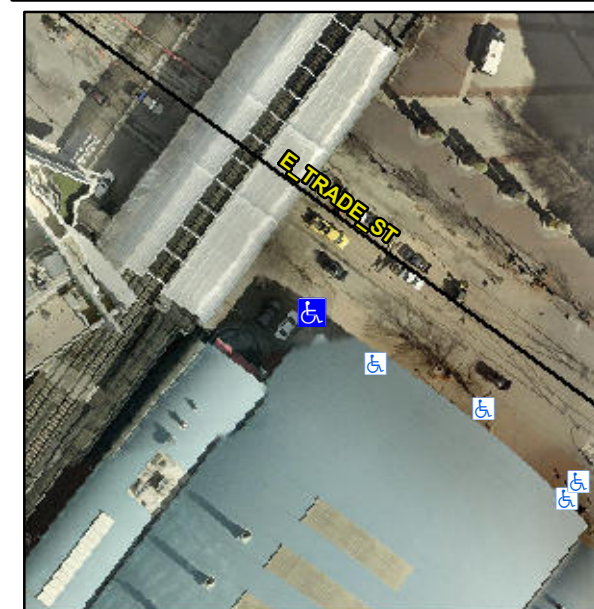
Compliance	Description	Data	Compliance	Description	Data
N/A	Ramp Length (in)	24.0	Yes	Ramp Slope (%)	7.0
Yes	Ramp Width (in)	48.0	Yes	Ramp XSlope (%)	3.6
N/A	Flare Type LT	Sloped	N/A	Flare Type RT	N/A
N/A	Flare Slope LT (%)	3.7	No	Flare Slope RT (%)	13.7
N/A	Flare Traversable LT?	Yes	N/A	Flare Traversable RT?	Yes
Yes	Landing Length (in)	48.0	Yes	DWS Provided?	Yes
Yes	Landing Width (in)	48.0	Yes	DWS Contrast?	Yes
No	Landing Slope (%)	3.4	Yes	DWS Length (in)	24.0
Yes	Landing X Slope (%)	3.0	Yes	DWS Full Width?	Yes
N/A	Landing Curb? (Y/N)	No	Yes	DWS Offset (in)	0.0
N/A	Shared Landing?	No			
Yes	Gutter Ponding?	No	Yes	Gutter Slope (%)	1.9
Yes	Gutter Lip Ht (in)	0.0	Yes	Gutter X Slope (%)	4.0
N/A	Painted X Walk1?	No	N/A	Painted X Walk2?	N/A
	X Walk 1 Direction	To SE		X Walk 2 Direction	N/A
N/A	X Walk 1 Width (in)	N/A	N/A	X Walk 2 Width (in)	N/A
	X Walk 1 Slope (%)	0.1		X Walk 2 Slope (%)	N/A
	X Walk 1 X Slope (%)	4.6		X Walk 2 X Slope (%)	N/A

N/A	Ramp inside XWalk1?	N/A	N/A	Ramp inside XWalk2?	N/A
	Road Slope (%)	N/A	N/A	Clear Space?	Yes
	Road X Slope (%)	N/A	N/A	Clear Space to XWalk (in)	N/A
Yes	Any Obstructions?	No	Yes	Storm Grate/Utility Hazard?	No
	Obstruction Type			Storm Grate/Utility Type	
		N/A			N/A
			Yes	Surface Condition? (G/P)	Good

Possible Solutions:

Remove & Replace Entire Ramp.
