# Access Compliance Report

## Public Rights-of-Way

### (Curb Ramps)

Intersection ID: 43535	Main Street: AMBROSIA_ST	Cross Street: PLANTERS_WATCH_DR	Location: SW
ADA ID: A71164E6AC62	Ramp Type: PerpDiag	Initial Pass/Fail: Fail	Overall Compliance: No
		Severity Score: 30

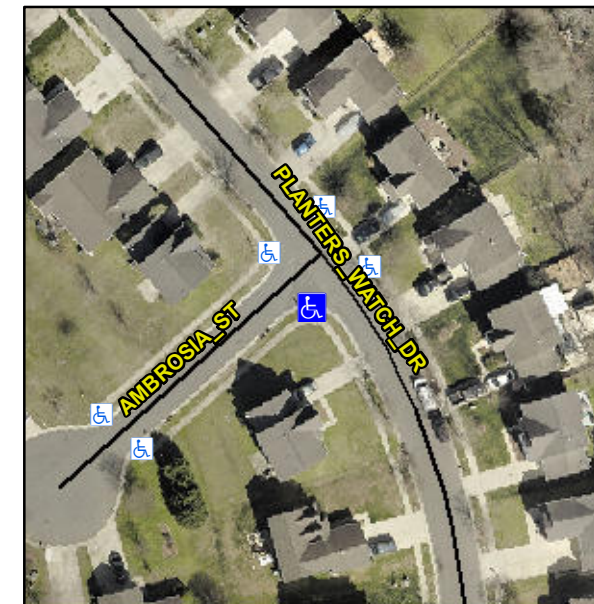
**R304.5.1, R304.5.3**

Compliance	Description	Data	Compliance	Description	Data
N/A	Ramp Length (in)	47.0	Yes	Ramp Slope (%)	5.6
No	Ramp Width (in)	35.0	No	Ramp XSlope (%)	5.1
N/A	Flare Type LT	N/A	N/A	Flare Type RT	N/A
N/A	Flare Slope LT (%)	N/A	N/A	Flare Slope RT (%)	N/A
N/A	Flare Traversable LT?	N/A	N/A	Flare Traversable RT?	N/A
N/A	Landing Length (in)	N/A	N/A	DWS Provided?	N/A
N/A	Landing Width (in)	N/A	N/A	DWS Contrast?	N/A
N/A	Landing Slope (%)	N/A	N/A	DWS Length (in)	N/A
N/A	Landing X Slope (%)	N/A	N/A	DWS Full Width?	N/A
N/A	Landing Curb? (Y/N)	N/A	N/A	DWS Offset (in)	N/A
N/A	Shared Landing?	N/A			
N/A	Gutter Ponding?	N/A	N/A	Gutter Slope (%)	N/A
N/A	Gutter Lip Ht (in)	N/A	N/A	Gutter X Slope (%)	N/A
N/A	Painted X Walk1?	No	N/A	Painted X Walk2?	No
	X Walk 1 Direction	To NE		X Walk 2 Direction	To NW
N/A	X Walk 1 Width (in)	N/A	N/A	X Walk 2 Width (in)	N/A
	X Walk 1 Slope (%)	3.0		X Walk 2 Slope (%)	1.3
	X Walk 1 X Slope (%)	0.5		X Walk 2 X Slope (%)	1.4

N/A	Ramp inside XWalk1?	N/A	N/A	Ramp inside XWalk2?	N/A
	Road Slope (%)	2.0	N/A	Clear Space?	N/A
	Road X Slope (%)	1.9	N/A	Clear Space to XWalk (in)	N/A
N/A	Any Obstructions?	N/A	N/A	Storm Grate/Utility Hazard?	N/A
	Obstruction Type			Storm Grate/Utility Type	
		N/A			N/A
			Yes	Surface Condition? (G/P)	Good

**Remove & Replace Curb Ramp With Two New Directional Ramps or Equivalent.**
