Access Compliance Report

Public Rights-of-Way

(Curb Ramps)

Intersection ID: 12957	Main Street: HAMORTON_PL	Cross Street: PECAN_AV	Location: NE
ADA ID: A717415B40F0	Ramp Type: PerpDiag	Initial Pass/Fail: Fail	Overall Compliance: No
		Severity Score: 12.5

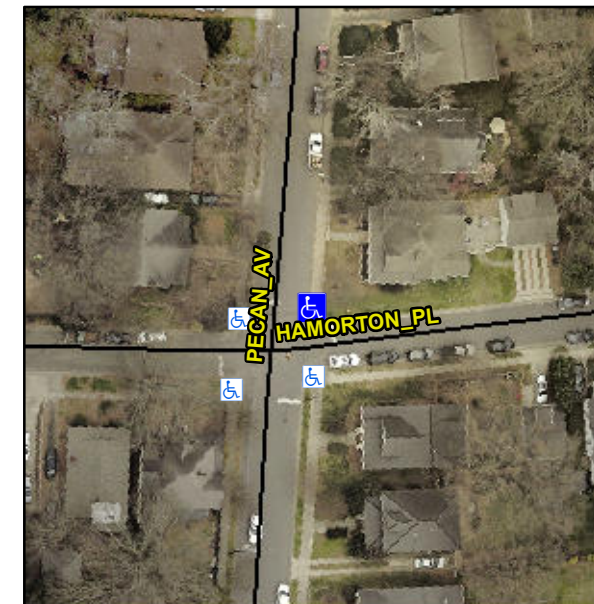
Not Found, R304.2.2

Compliance	Description	Data	Compliance	Description	Data
N/A	Ramp Length (in)	48.0	No	Ramp Slope (%)	9.5
Yes	Ramp Width (in)	48.0	Yes	Ramp XSlope (%)	1.4
N/A	Flare Type LT	N/A	N/A	Flare Type RT	N/A
N/A	Flare Slope LT (%)	N/A	N/A	Flare Slope RT (%)	N/A
N/A	Flare Traversable LT?	N/A	N/A	Flare Traversable RT?	N/A
N/A	Landing Length (in)	N/A	N/A	DWS Provided?	N/A
N/A	Landing Width (in)	N/A	N/A	DWS Contrast?	N/A
N/A	Landing Slope (%)	N/A	N/A	DWS Length (in)	N/A
N/A	Landing X Slope (%)	N/A	N/A	DWS Full Width?	N/A
N/A	Landing Curb? (Y/N)	N/A	N/A	DWS Offset (in)	N/A
N/A	Shared Landing?	N/A			
N/A	Gutter Ponding?	Yes	N/A	Gutter Slope (%)	N/A
N/A	Gutter Lip Ht (in)	1.0	N/A	Gutter X Slope (%)	N/A
N/A	Painted X Walk1?	No	N/A	Painted X Walk2?	No
	X Walk 1 Direction	To W		X Walk 2 Direction	To S
N/A	X Walk 1 Width (in)	N/A	N/A	X Walk 2 Width (in)	N/A
	X Walk 1 Slope (%)	1.4		X Walk 2 Slope (%)	0.8
	X Walk 1 X Slope (%)	0.1		X Walk 2 X Slope (%)	1.8

N/A	Ramp inside XWalk1?	N/A	N/A	Ramp inside XWalk2?	N/A
	Road Slope (%)	1.0	N/A	Clear Space?	N/A
	Road X Slope (%)	0.5	N/A	Clear Space to XWalk (in)	N/A
N/A	Any Obstructions?	N/A	N/A	Storm Grate/Utility Hazard?	N/A
	Obstruction Type			Storm Grate/Utility Type	
		N/A			N/A
		Yes		Surface Condition? (G/P)	Good

Possible Solutions:

Remove & Replace Curb Ramp With Two New Directional Ramps or Equivalent.
