# Access Compliance Report

## Public Rights-of-Way

### (Curb Ramps)

| Intersection ID: 14461 | Main Street: E_WORTHINGTON_AV | Cross Street: LYNDHURST_AV | Location: E |

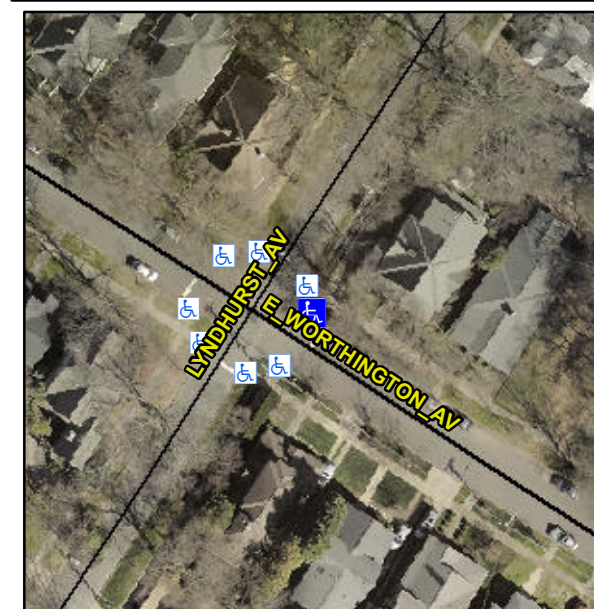
| ADA ID: A719F2ABF048 | Ramp Type: Perp | Initial Pass/Fail: Fail | Overall Compliance: No |
| Severity Score: 10 | | | |

**R304.5.1, R304.5.3**

| Compliance | Description | Data | Compliance | Description | Data |
|---|---|---|---|---|---|
| N/A | Ramp Length (in) | 68.0 | Yes | Ramp Slope (%) | 7.9 |
| No | Ramp Width (in) | 36.0 | No | Ramp XSlope (%) | 2.9 |

**Remove & Replace Entire Ramp.**

Total Cost: \$ 1850.00
