Access Compliance Report

Public Rights-of-Way

(Curb Ramps)

Intersection ID: 54156	Main Street: OAKDALE RIDGE RD	Cross Street: MAPLE CREEK CT	Location: NW
ADA ID: A71B1B48FCCC	Ramp Type: Perp	Initial Pass/Fail: Fail	Overall Compliance: No
Severity Score: 8.75			
Codes/Mitigation Info/Possible Solution		Field Measurements/Component Compliance

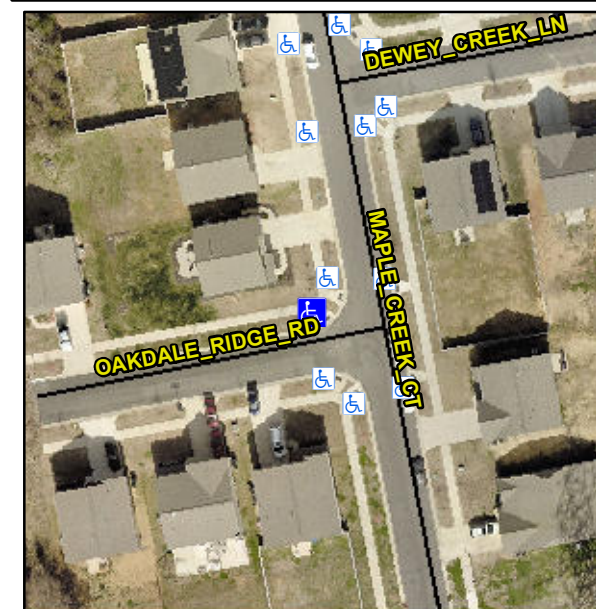
Compliance	Description	Data	Compliance	Description	Data
N/A	Ramp Length (in)	97.5	Yes	Ramp Slope (%)	7.1
No	Ramp Width (in)	44.0	Yes	Ramp XSlope (%)	1.3
N/A	Flare Type LT	N/A	N/A	Flare Type RT	N/A
N/A	Flare Slope LT (%)	N/A	N/A	Flare Slope RT (%)	N/A
N/A	Flare Traversable LT?	N/A	N/A	Flare Traversable RT?	N/A
N/A	Landing Length (in)	N/A	N/A	DWS Provided?	N/A
N/A	Landing Width (in)	N/A	N/A	DWS Contrast?	N/A
N/A	Landing Slope (%)	N/A	N/A	DWS Length (in)	N/A
N/A	Landing X Slope (%)	N/A	N/A	DWS Full Width?	N/A
N/A	Landing Curb? (Y/N)	N/A	N/A	DWS Offset (in)	N/A
N/A	Shared Landing?	N/A			
N/A	Gutter Ponding?	N/A	N/A	Gutter Slope (%)	N/A
N/A	Gutter Lip Ht (in)	1.0	N/A	Gutter X Slope (%)	N/A
N/A	Painted X Walk1?	No	N/A	Painted X Walk2?	N/A
	X Walk 1 Direction	To S		X Walk 2 Direction	N/A
N/A	X Walk 1 Width (in)	N/A	N/A	X Walk 2 Width (in)	N/A
	X Walk 1 Slope (%)	1.6		X Walk 2 Slope (%)	N/A
	X Walk 1 X Slope (%)	0.9		X Walk 2 X Slope (%)	N/A

N/A	Ramp inside XWalk1?	N/A	N/A	Ramp inside XWalk2?	N/A
	Road Slope (%)	N/A	N/A	Clear Space?	N/A
	Road X Slope (%)	N/A	N/A	Clear Space to XWalk (in)	N/A
N/A	Any Obstructions?	N/A	N/A	Storm Grate/Utility Hazard?	N/A
	Obstruction Type			Storm Grate/Utility Type	
		N/A			N/A
			Yes	Surface Condition? (G/P)	Good

Possible Solutions:

Remove & Replace Entire Ramp.

Not Found, R304.5.1

Total Cost: \$ 1850.00
