Access Compliance Report

Public Rights-of-Way

(Curb Ramps)

Intersection ID: N/A	Main Street: NATIONS_FORD_RD	Cross Street: N/A	Location: N
ADA ID: A71E1B37F5FD	Ramp Type: PerpDiag	Initial Pass/Fail: Fail	Overall Compliance: No
Severity Score: 12.5			
Codes/Mitigation Info/Possible Solution		Field Measurements/Component Compliance

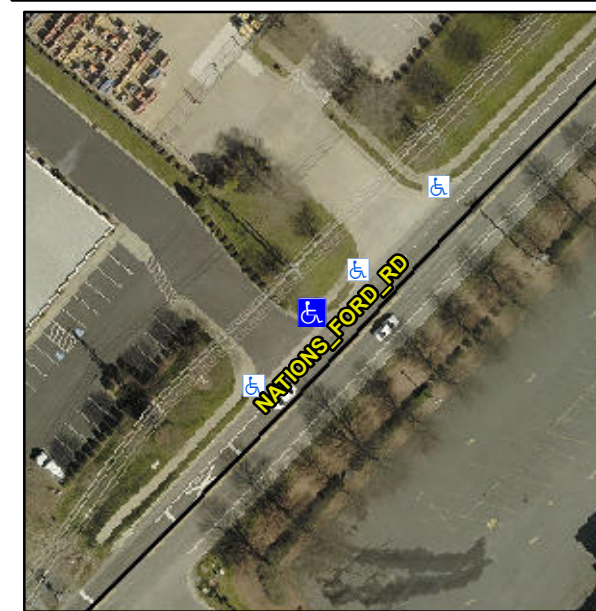
Compliance	Description	Data	Compliance	Description	Data
N/A	Ramp Length (in)	48.0	No	Ramp Slope (%)	9.5
Yes	Ramp Width (in)	48.0	Yes	Ramp XSlope (%)	0.9
N/A	Flare Type LT	N/A	N/A	Flare Type RT	N/A
N/A	Flare Slope LT (%)	N/A	N/A	Flare Slope RT (%)	N/A
N/A	Flare Traversable LT?	No	N/A	Flare Traversable RT?	No
N/A	Landing Length (in)	N/A	N/A	DWS Provided?	N/A
N/A	Landing Width (in)	N/A	N/A	DWS Contrast?	N/A
N/A	Landing Slope (%)	N/A	N/A	DWS Length (in)	N/A
N/A	Landing X Slope (%)	N/A	N/A	DWS Full Width?	N/A
N/A	Landing Curb? (Y/N)	N/A	N/A	DWS Offset (in)	N/A
N/A	Shared Landing?	N/A			
N/A	Gutter Ponding?	N/A	N/A	Gutter Slope (%)	N/A
N/A	Gutter Lip Ht (in)	N/A	N/A	Gutter X Slope (%)	N/A
N/A	Painted X Walk1?	No	N/A	Painted X Walk2?	No
	X Walk 1 Direction	To SW		X Walk 2 Direction	To SE
N/A	X Walk 1 Width (in)	N/A	N/A	X Walk 2 Width (in)	N/A
	X Walk 1 Slope (%)	2.0		X Walk 2 Slope (%)	5.6
	X Walk 1 X Slope (%)	3.5		X Walk 2 X Slope (%)	1.2

N/A	Ramp inside XWalk1?	N/A	N/A	Ramp inside XWalk2?	N/A
	Road Slope (%)	5.4	N/A	Clear Space?	N/A
	Road X Slope (%)	3.4	N/A	Clear Space to XWalk (in)	N/A
N/A	Any Obstructions?	N/A	N/A	Storm Grate/Utility Hazard?	N/A
	Obstruction Type			Storm Grate/Utility Type	
		N/A			N/A
			Yes	Surface Condition? (G/P)	Good

Possible Solutions:

Remove & Replace Curb Ramp With Two New Directional Ramps or Equivalent.

R304.2.2

Total Cost: \$ 3200.00
