# Access Compliance Report

## Public Rights-of-Way

### (Curb Ramps)

Intersection ID: 29523	Main Street: SEDGEWOOD_CR	Cross Street: SEDGEWOOD_PLACE_CT	Location: E
ADA ID: A7246CF2EE7E	Ramp Type: PerpDiag	Initial Pass/Fail: Fail	Overall Compliance: No
			Severity Score: 13.75

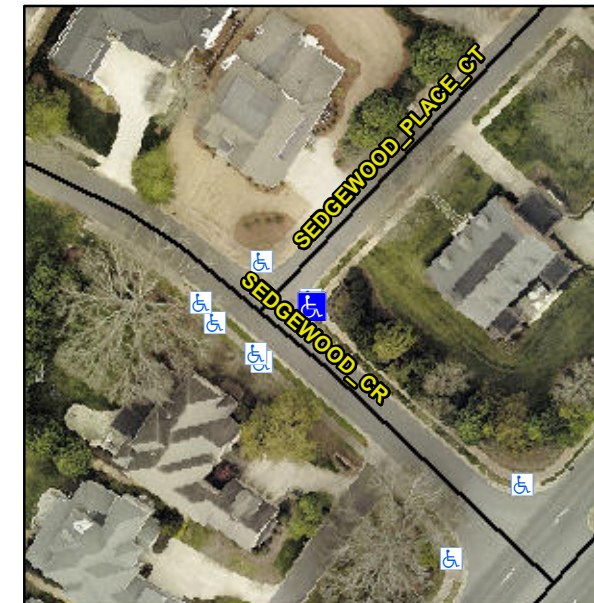
**Not Found, R304.2.2, R304.5.3**

Compliance	Description	Data	Compliance	Description	Data
N/A	Ramp Length (in)	48.0	No	Ramp Slope (%)	9.0
Yes	Ramp Width (in)	48.0	No	Ramp XSlope (%)	2.1
N/A	Flare Type LT	N/A	N/A	Flare Type RT	N/A
N/A	Flare Slope LT (%)	N/A	N/A	Flare Slope RT (%)	N/A
N/A	Flare Traversable LT?	N/A	N/A	Flare Traversable RT?	N/A
N/A	Landing Length (in)	N/A	N/A	DWS Provided?	N/A
N/A	Landing Width (in)	N/A	N/A	DWS Contrast?	N/A
N/A	Landing Slope (%)	N/A	N/A	DWS Length (in)	N/A
N/A	Landing X Slope (%)	N/A	N/A	DWS Full Width?	N/A
N/A	Landing Curb? (Y/N)	N/A	N/A	DWS Offset (in)	N/A
N/A	Shared Landing?	N/A			
N/A	Gutter Ponding?	N/A	N/A	Gutter Slope (%)	N/A
N/A	Gutter Lip Ht (in)	N/A	N/A	Gutter X Slope (%)	N/A
N/A	Painted X Walk1?	No	N/A	Painted X Walk2?	No
	X Walk 1 Direction	To NW		X Walk 2 Direction	To SW
N/A	X Walk 1 Width (in)	N/A	N/A	X Walk 2 Width (in)	N/A
	X Walk 1 Slope (%)	0.2		X Walk 2 Slope (%)	2.2
	X Walk 1 X Slope (%)	7.7		X Walk 2 X Slope (%)	0.8

N/A	Ramp inside XWalk1?	N/A	N/A	Ramp inside XWalk2?	N/A
	Road Slope (%)	1.4	N/A	Clear Space?	N/A
	Road X Slope (%)	2.6	N/A	Clear Space to XWalk (in)	N/A
N/A	Any Obstructions?	N/A	N/A	Storm Grate/Utility Hazard?	N/A
	Obstruction Type			Storm Grate/Utility Type	
		N/A			N/A
			Yes	Surface Condition? (G/P)	Good

**Remove & Replace Curb Ramp With Two New Directional Ramps or Equivalent.**

Total Cost: \$ 3200.00
