Access Compliance Report

Public Rights-of-Way

(Curb Ramps)

Intersection ID: 49802	Main Street: ATKINS RIDGE DR	Cross Street: GANDOLFO CT	Location: W
ADA ID: A73D90ACE7E3	Ramp Type: Perp	Initial Pass/Fail: Fail	Overall Compliance: No
Severity Score: 12.5			
Codes/Mitigation Info/Possible Solution		Field Measurements/Component Compliance

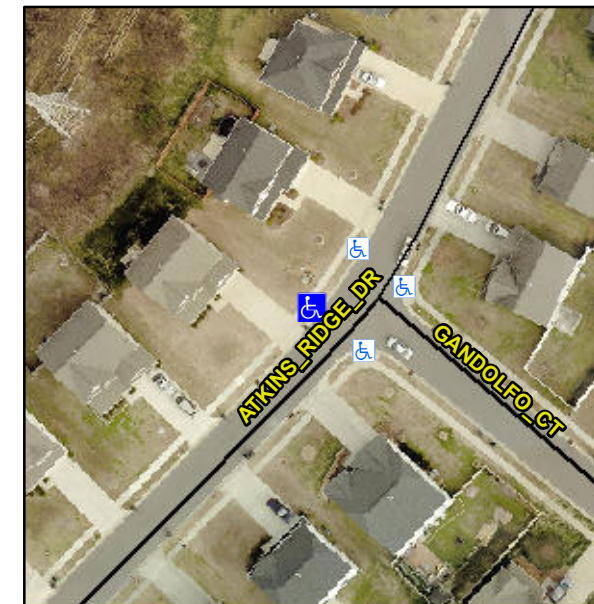
Not Found, R304.5.3

Compliance	Description	Data	Compliance	Description	Data
N/A	Ramp Length (in)	47.0	Yes	Ramp Slope (%)	6.0
Yes	Ramp Width (in)	48.0	No	Ramp XSlope (%)	5.5
N/A	Flare Type LT	N/A	N/A	Flare Type RT	N/A
N/A	Flare Slope LT (%)	N/A	N/A	Flare Slope RT (%)	N/A
N/A	Flare Traversable LT?	N/A	N/A	Flare Traversable RT?	N/A
N/A	Landing Length (in)	N/A	N/A	DWS Provided?	N/A
N/A	Landing Width (in)	N/A	N/A	DWS Contrast?	N/A
N/A	Landing Slope (%)	N/A	N/A	DWS Length (in)	N/A
N/A	Landing X Slope (%)	N/A	N/A	DWS Full Width?	N/A
N/A	Landing Curb? (Y/N)	N/A	N/A	DWS Offset (in)	N/A
N/A	Shared Landing?	N/A			
N/A	Gutter Ponding?	N/A	N/A	Gutter Slope (%)	N/A
N/A	Gutter Lip Ht (in)	N/A	N/A	Gutter X Slope (%)	N/A
N/A	Painted X Walk1?	No	N/A	Painted X Walk2?	N/A
	X Walk 1 Direction	To SE		X Walk 2 Direction	N/A
N/A	X Walk 1 Width (in)	N/A	N/A	X Walk 2 Width (in)	N/A
	X Walk 1 Slope (%)	2.1		X Walk 2 Slope (%)	N/A
	X Walk 1 X Slope (%)	5.8		X Walk 2 X Slope (%)	N/A

N/A	Ramp inside XWalk1?	N/A	N/A	Ramp inside XWalk2?	N/A
	Road Slope (%)	N/A	N/A	Clear Space?	N/A
	Road X Slope (%)	N/A	N/A	Clear Space to XWalk (in)	N/A
N/A	Any Obstructions?	N/A	N/A	Storm Grate/Utility Hazard?	N/A
	Obstruction Type			Storm Grate/Utility Type	
		N/A			N/A
			Yes	Surface Condition? (G/P)	Good

Possible Solutions:

Remove & Replace Entire Ramp.
